The Lampreys of the Grass Valley Drainage:

Distribution and Passage Barriers, 2016

including an Assessment of Buckhorn Dam as a barrier to Pacific Lamprey

Submitted under Contract: Grass Valley Creek Anadromous Pacific Lamprey: sediment management and connectivity (Trinity River Resource Conservation District / funding Trinity River Restoration Program), 30 August 2017.

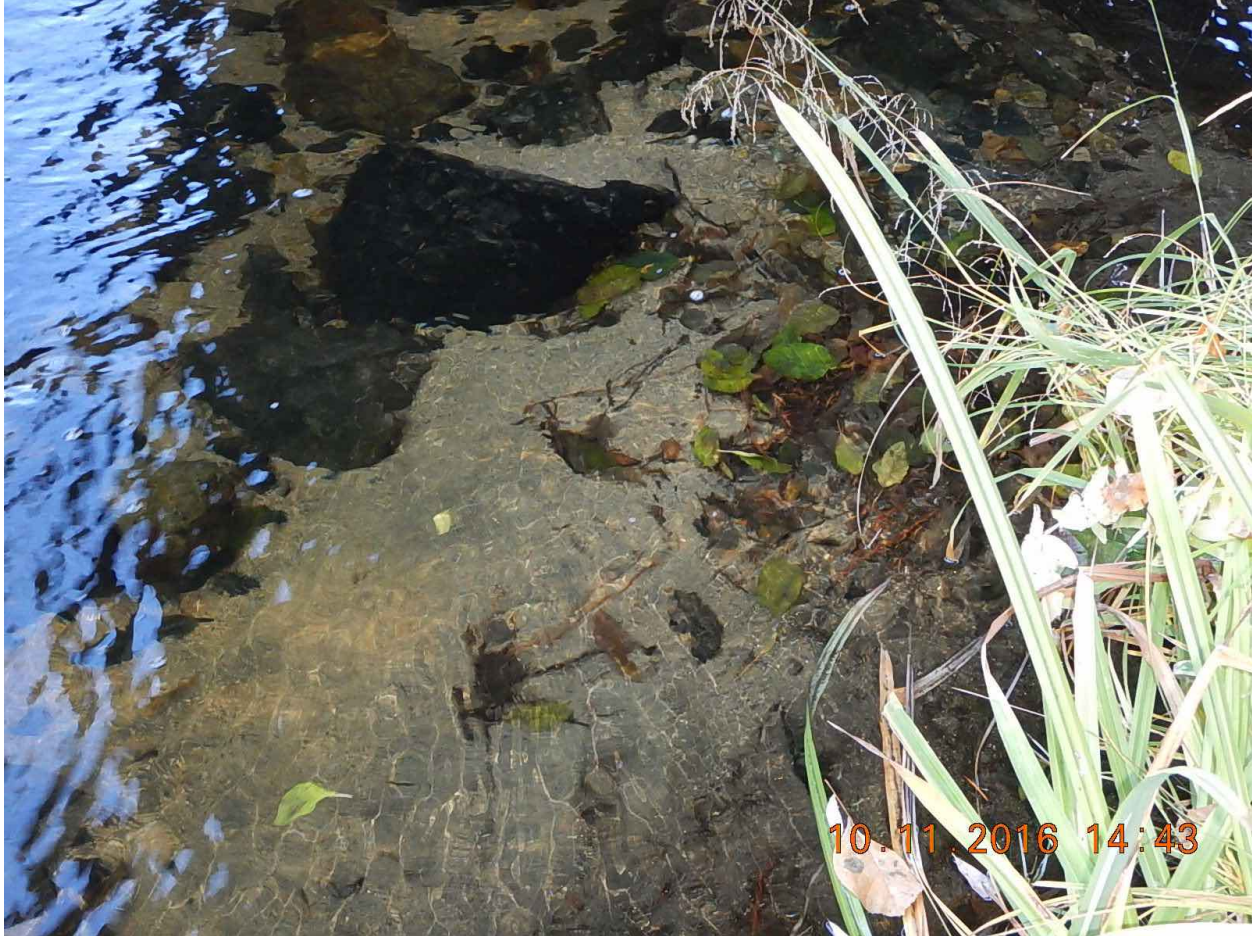
Figure 6. Ammocoete habitat at the Fawn Lodge Highway 299 bridge. This was the only site above Hamilton Ponds with > 4 ammocoetes encountered in a pool. At least 100 ammocoetes and five juveniles were observed here. Note low gradient, open sands, silt and leaf litter.

Discussion: Ammocoete abundance in Grass Valley Creek was notably low, generally 0-4 per pool, except at the Fawn Lodge Highway 299 bridge (Figure 5) and in the Hamilton Ponds. Above the Highway 299 bridge they also exhibited a truncated size-distribution, with only a single individual below 12 cm TL. The ammocoetes phase is typically 5-7 years long, and a 12 cm ammocoete is approximately four years old (Beamish and Medland 1988, Meeuwig and Bayer 2005, Reid unpub. data).

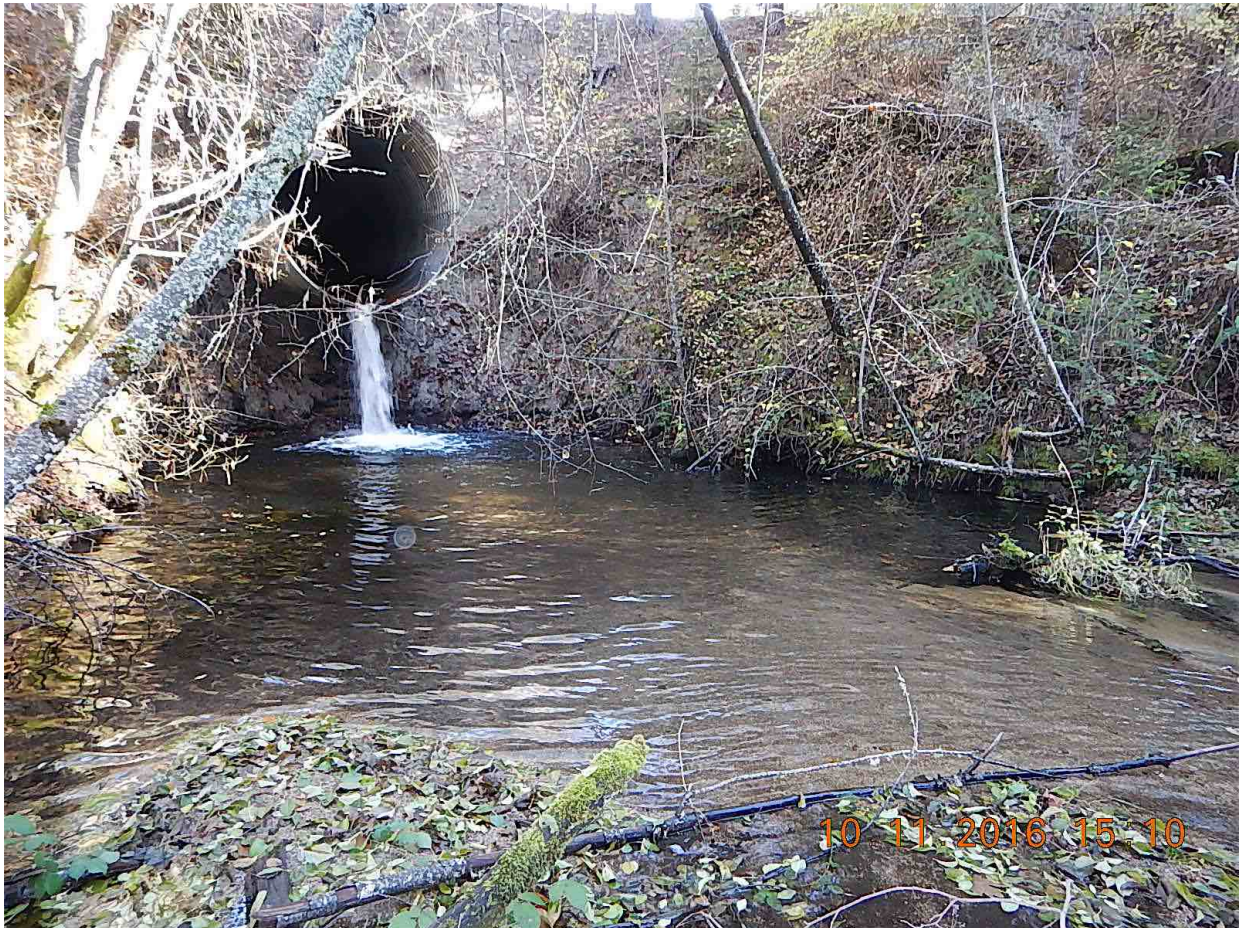
Figure 8. Barrier #1 (Little Grass Valley Creek, see map) - I.O.O.F. entry on lower Little Grass Valley Creek. This is a large perched culvert (5 ft drop) that blocks the drainage, 600m upstream of the confluence with Grass Valley mainstem.

Barrier #1 (Figure 8) - The I.O.O.F. entry over Little Grass Valley Creek is fully blocked by a large perched culvert (5 ft drop) 600m upstream of the confluence with Grass Valley mainstem. This is a complete barrier to passage. Remediation would require replacement with a bridge, a new culvert at/below channel elevation, or a lamprey-specific passage route.

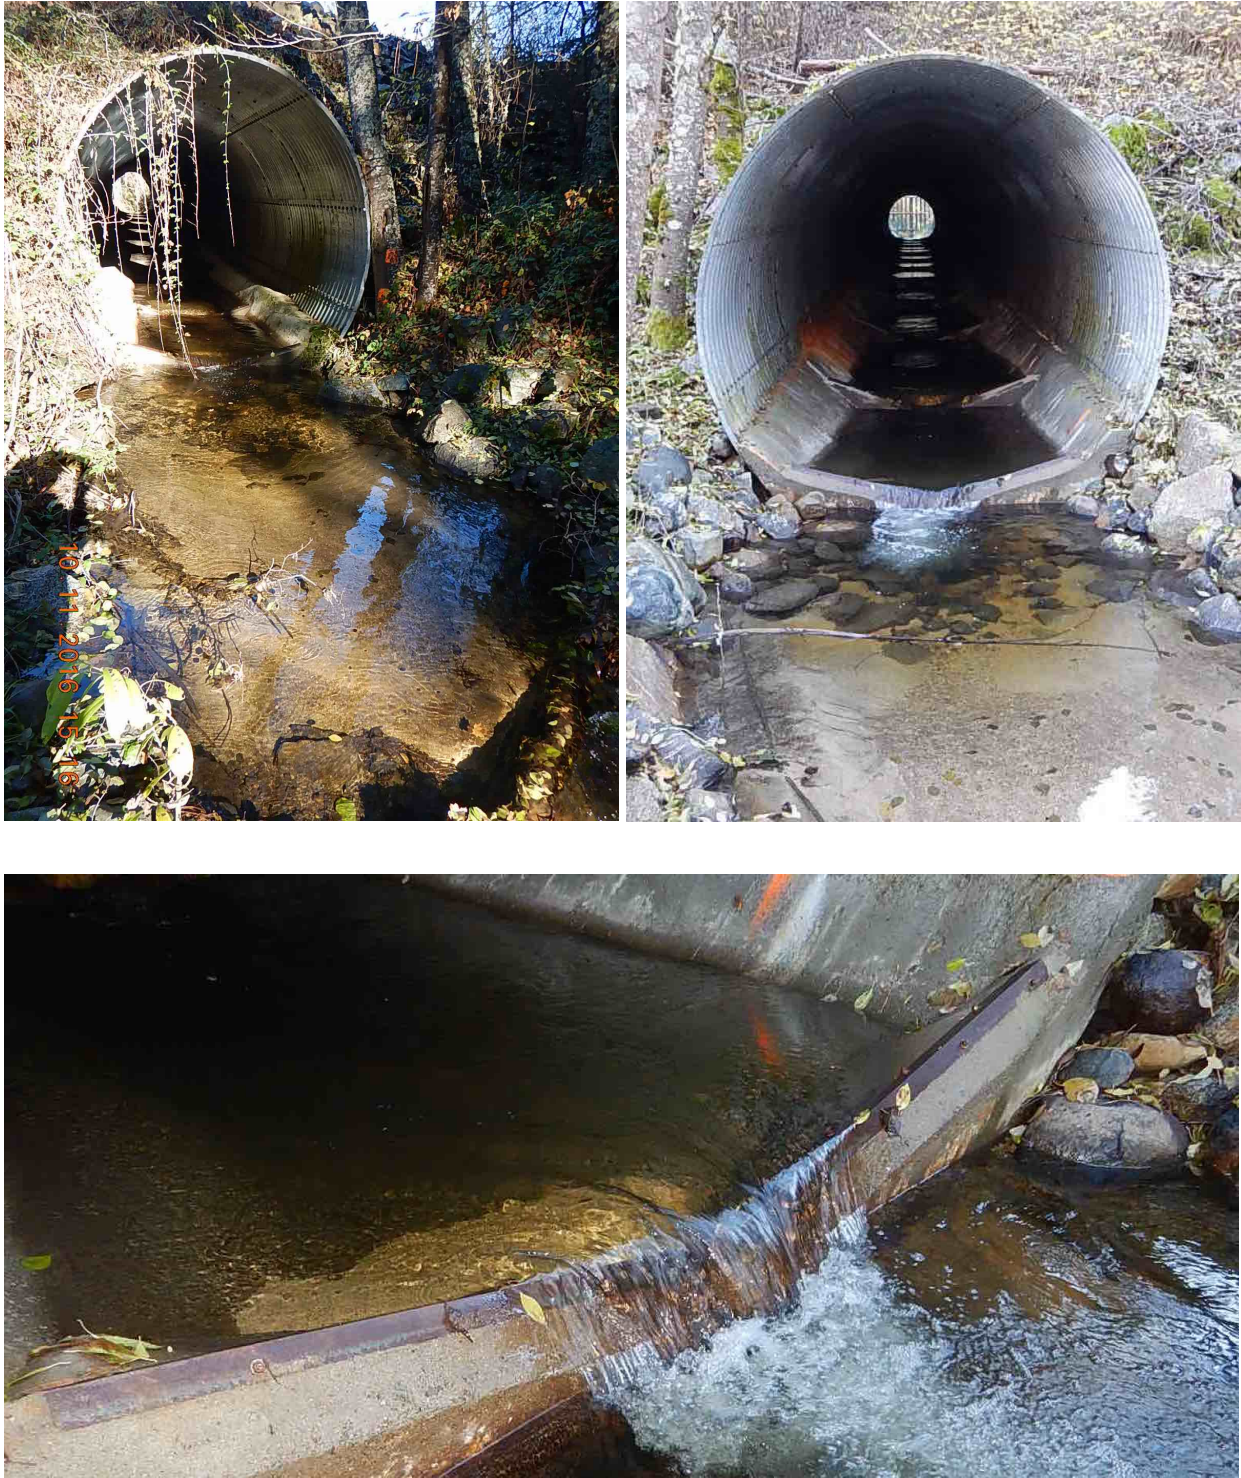
Figure 9. Barriers #2 a,b - Highway 299 culverts at Buckhorn Station.
A) entry to lower culvert, B) entry to upper culvert, C) interior baffle design.

Barrier #2 a, b (Figure 9 - Highway 299 culverts (2) at Buckhorn Station. Both have essentially submerged entries. The interior baffles, while capped by 90° angle iron, have low drops (2-4") that area easily swimmable at low flows/velocities. As flows increase, passage (burst-attach or climbing) is available either over the baffles along the smoothly rounded concrete side-walls or corrugated culvert. These culverts represent a partial passage impediment due to their length and increased effort to pass, but are not impassable and would not particularly benefit by modification, other than replacement with a fully natural bottom.

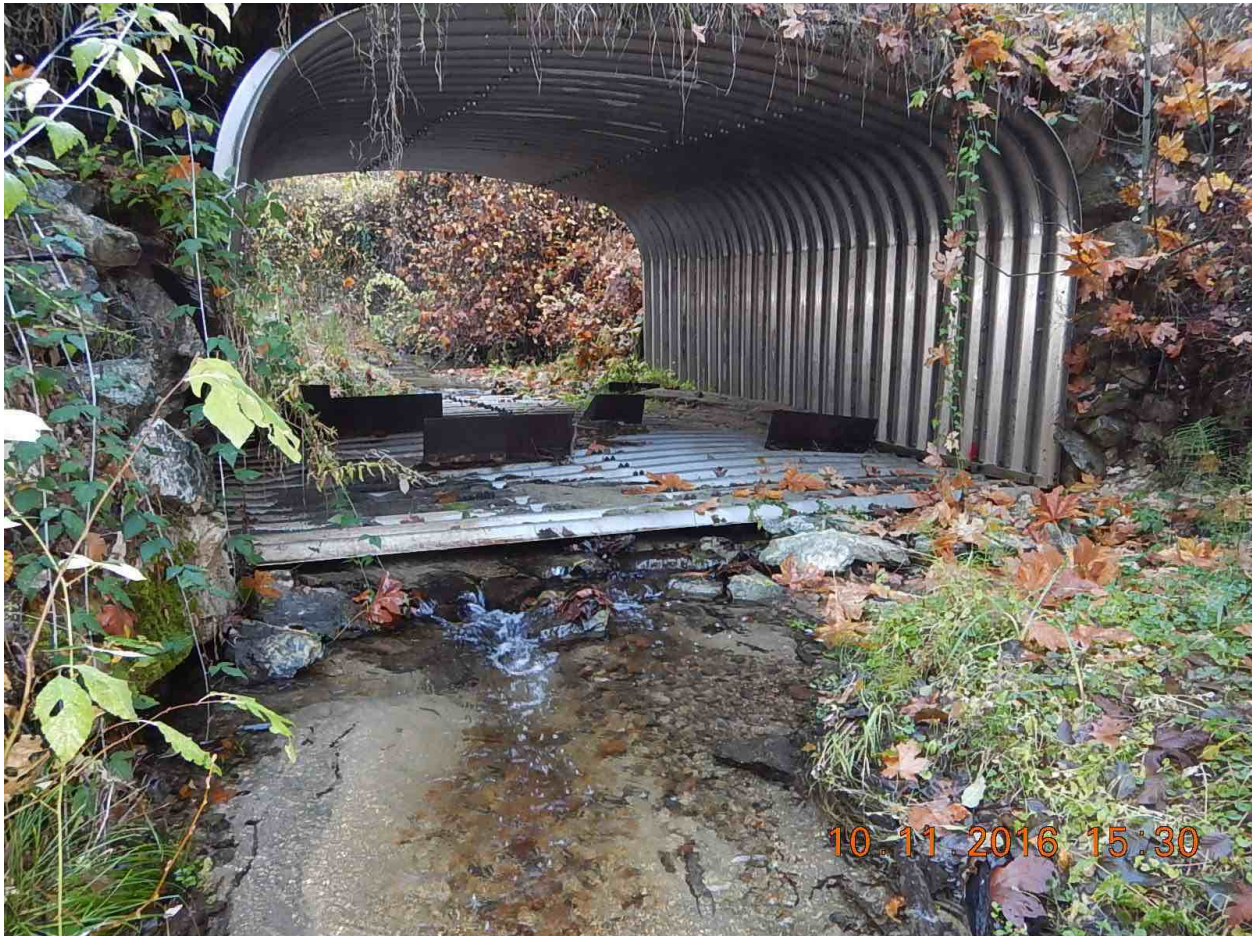
Figure 10. Barrier #3 - The decommissioned BLM road culvert is passable either by burst-attach swimming through the flat-bottomed culvert or, more probably, by crawling underneath. The stream has fully excavated under the culvert bottom, providing unimpeded passage.

Barrier #3 (Figure 10) - The decommissioned BLM road culvert is passable either by burst-attach swimming through the flat-bottomed culvert or, more probably, by crawling underneath. The stream has fully excavated under the culvert bottom, providing unimpeded passage. This culvert is not a barrier to lamprey passage, due to the availability of a natural bottom underneath.

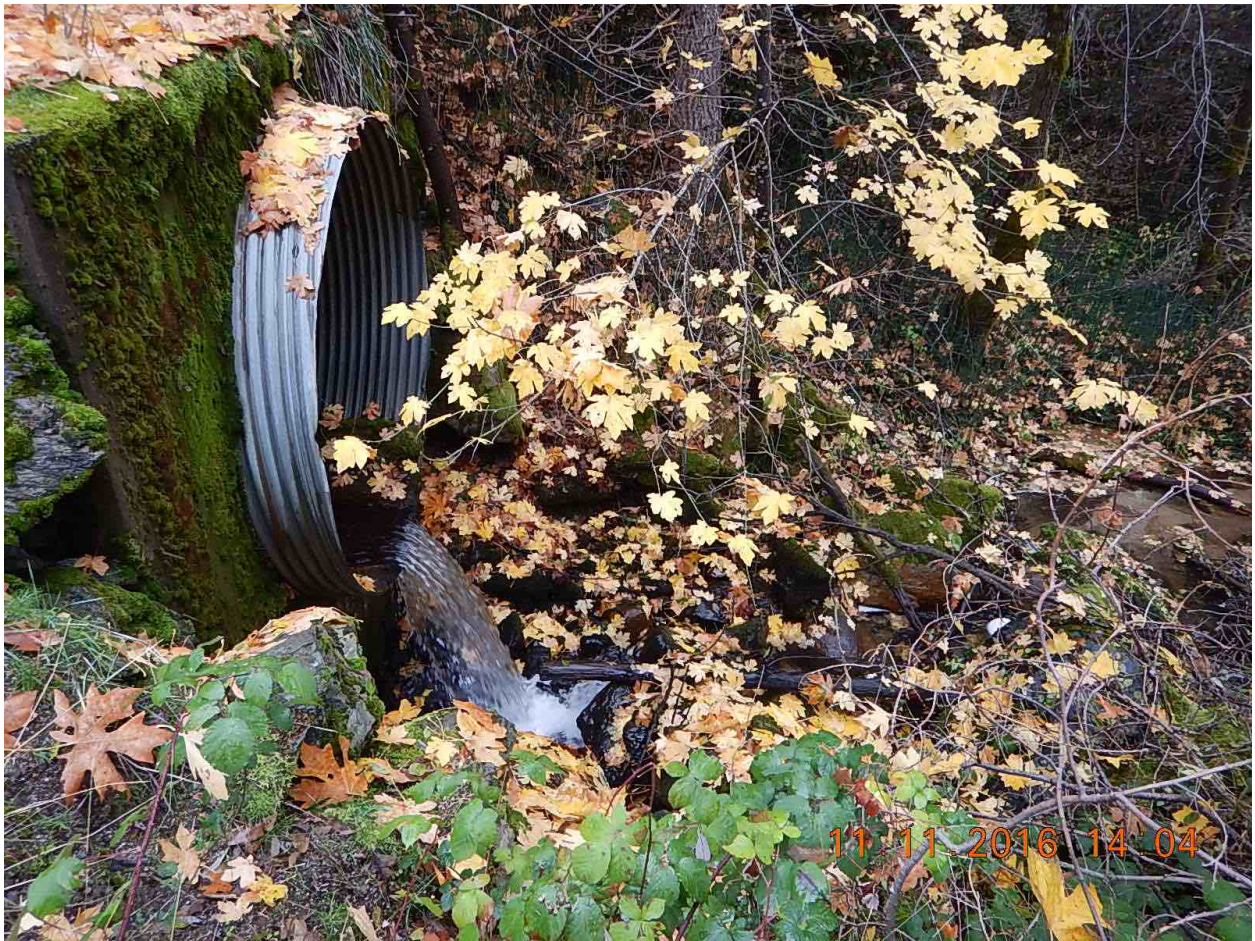
Figure 11. Barrier #4 - Private entry (TriL Ranch), a perched culvert (5 ft drop) with an overhanging edge and impassable.

Barrier #4 (Figure 11) - The private entry (TriL Ranch) is a perched culvert (5 ft drop) that sticks about 1 ft out of a concrete wall. This is a complete barrier to passage. Remediation would require replacement with a bridge, a new culvert at/below channel elevation, or a lamprey-specific passage route.

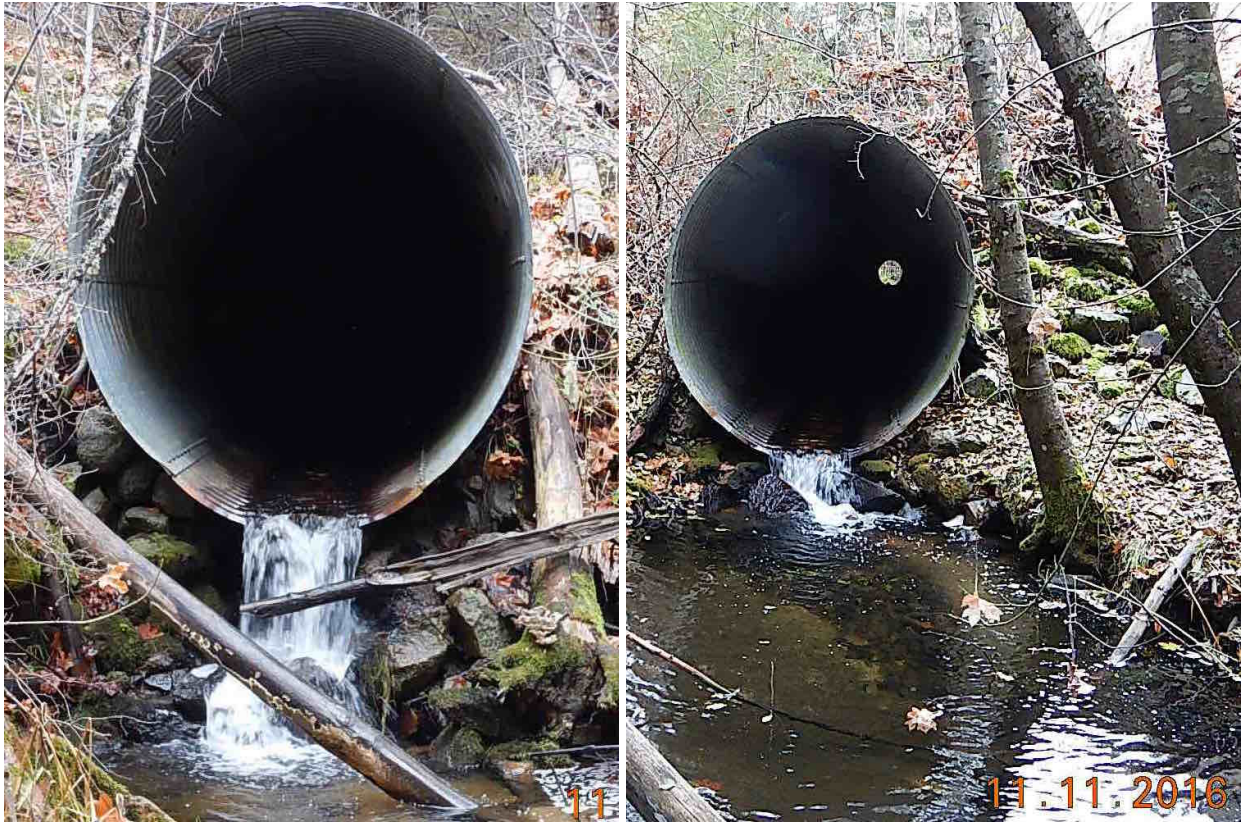
Figure 12. Barriers #5 a, b - Highway 299 "double-crossing" culverts below Buckhorn Summit. A) entry to lower culvert, B) entry to upper culvert.

Barriers #5 a, b (Figure 12) - The Highway 299 "double-crossing" culverts below Buckhorn Summit are both perched with overhanging edges and low-flow drops at their entries. The lower culvert is the greater challenge, with a 3 ft drop to stream surface; the rocks under the lip provide no access to the culvert. The upper culvert is somewhat better, with a lower drop (1 ft) and currently with a large rock that provides an attachment surface up onto the culvert lip - it is not ideal or permanent. In their current configuration the culvert pair represent a complete barrier to lampreys, since at flows high enough to submerge the entries velocities would be too high to pass upstream. Remediation of these culverts would probably require either raising the outlet pool elevation to submerge their entries, proving a smooth ramped entry or replacement with a bottom at channel elevation.

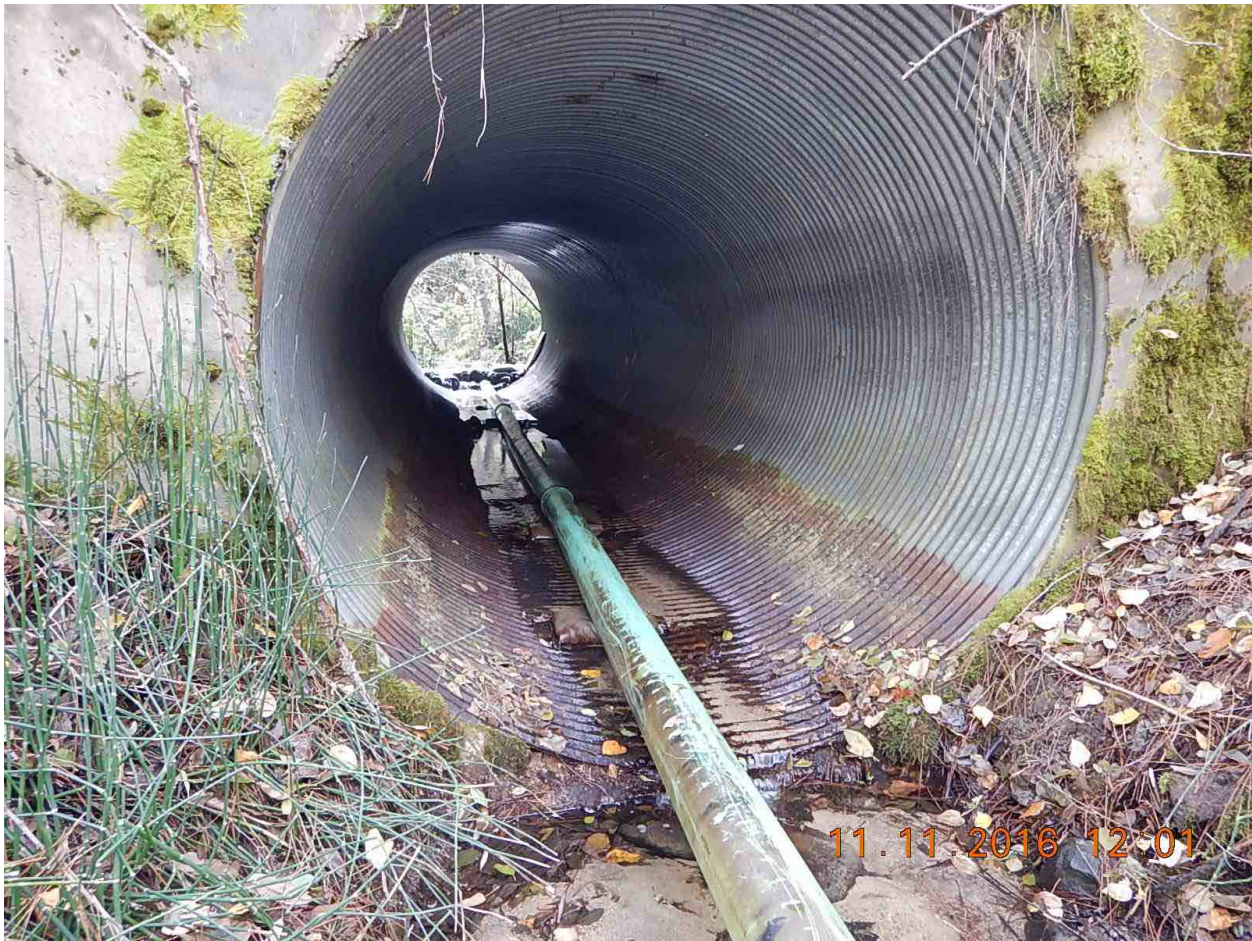
Figure 13. Barrier #6 - Shingle Shanty crossing, Buckhorn Dam road. The relatively short culvert represents a minor passage impediment due some increased effort to pass at higher velocities. It would not particularly benefit by modification, other than replacement with a fully natural bottom.

Barrier #6 (Figure 13) - Shingle Shanty crossing, Buckhorn Dam road. This culvert has a minor entry drop (3 in) that is submerged at most flows. The relatively short length (ca. 30 ft) and unobstructed corrugations represent a minor passage impediment due some increased effort to pass at higher velocities. It would not particularly benefit by modification, other than replacement with a fully natural bottom.

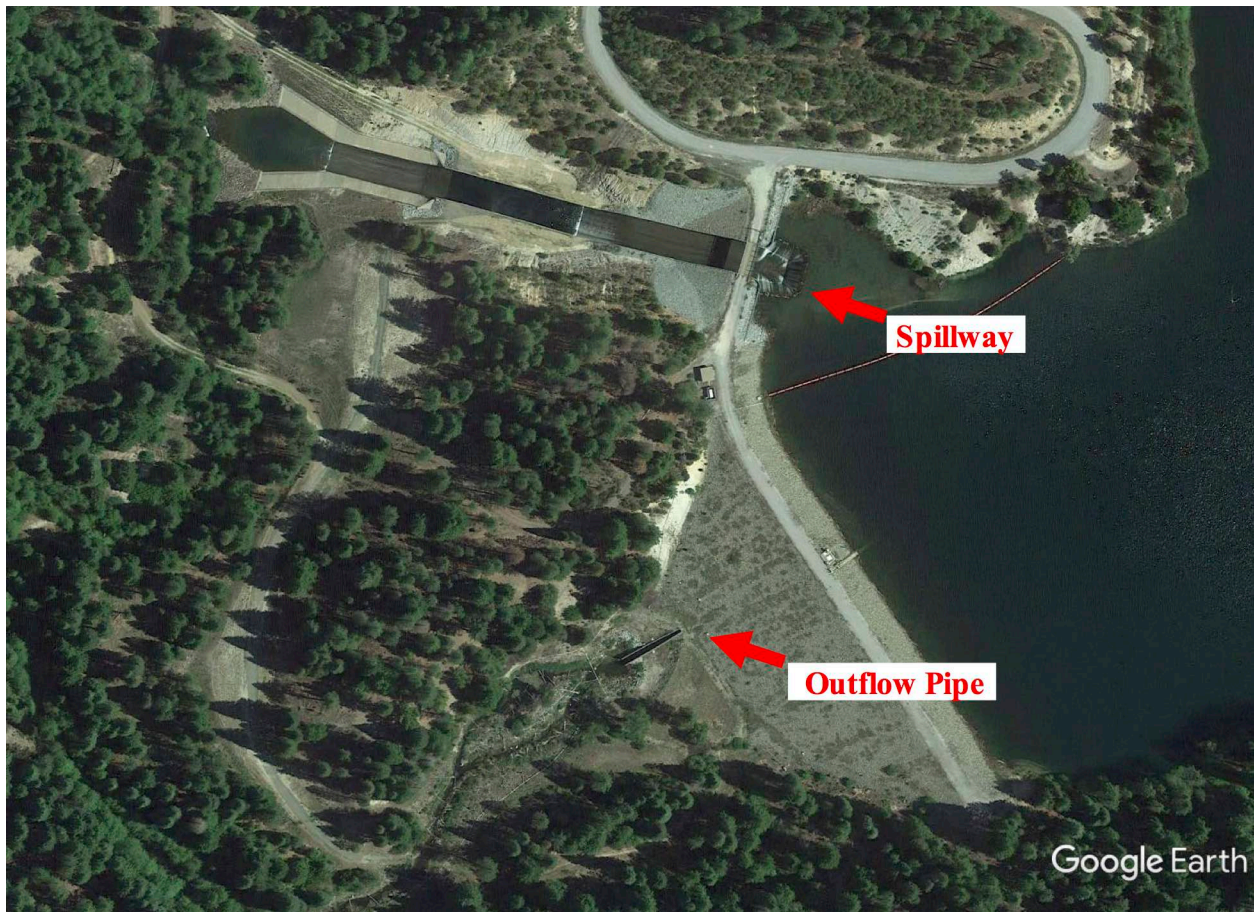
Background: Buckhorn Dam, constructed in 1991 to retain sediment forms a run-of-the-river reservoir with no irrigation or power generation (Figure 14). It's primary release route is an overflow spillway, with a secondary toe-drain outflow that releases water at the dam base. The dam is 92 ft tall and the total length of spillway is about 700 ft (including 455 ft of ramp and a 20 ft of wall; Figure 16). The long axis of the spillway crest is ~ 150 ft and ramp width is ~75 ft wide. The spillway elevation is 2803.0 ft ASL. Total elevation change is 92 ft to the lower pool.

Figure 14. Buckhorn Dam, 28 May 2016. Reservoir elevation at overflow is 2803.0 ft ASL. Total dam height is 92 ft.

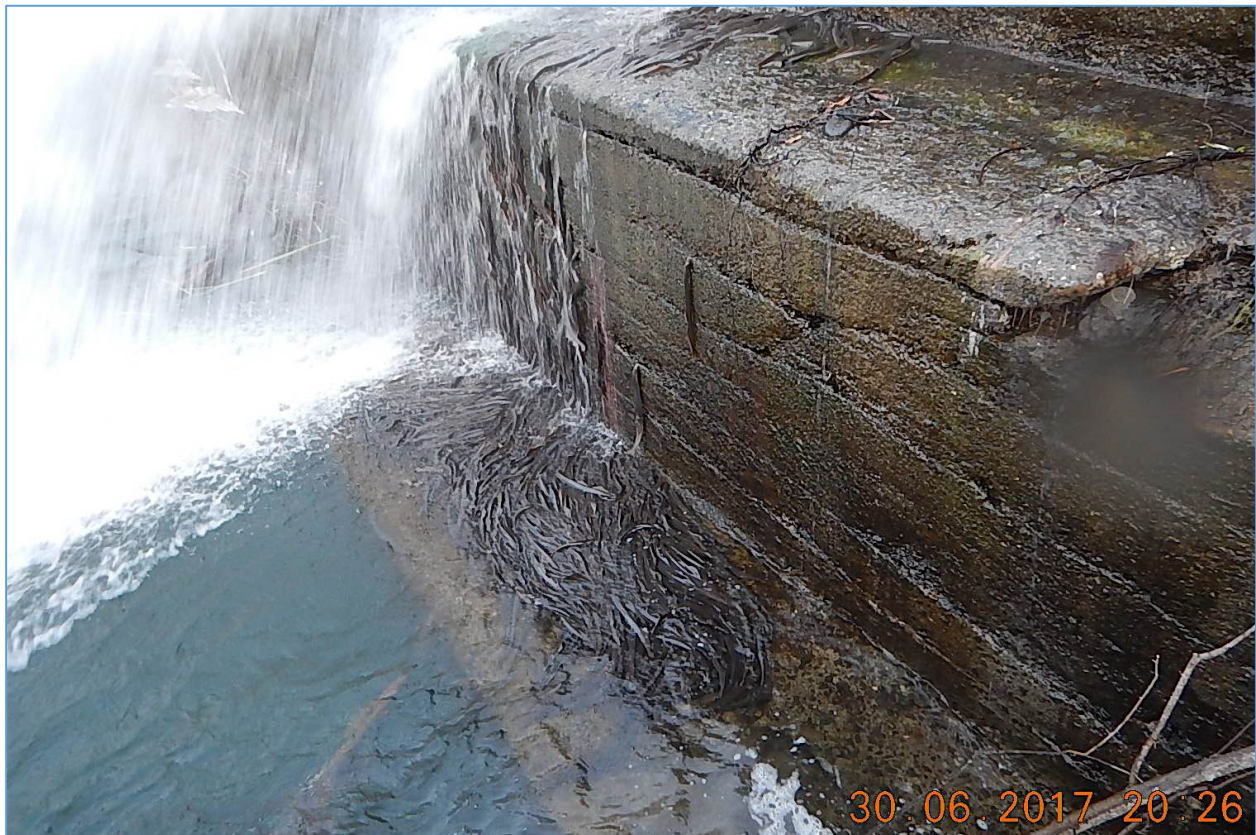
Figure 15. Pacific Lamprey climbing a vertical concrete wall.

The anadromous Pacific Lamprey is considered the most athletic climber in the family Petromyzontiformes (Goodman and Reid 2017). They regularly ascend waterfalls, cascades and man-made obstructions, when feasible, during upstream migrations (Figure 15). They climb by means of suctional attachment, release and reattachment, typically ascending subaerial inclined and vertical wetted surfaces with an energetically efficient dyno-climbing behavior (derived from mountaineering terminology), flexing the body in a waveform, then extending upward and reattaching by means of their sucker mouth (Zhu et al. 2011). During climbing ascents, lampreys will typically seek subaerial routes where lower velocities exist outside of primary flow, such as shallow flow or even splash zones, where they are partially or completely out of the water (Miller 2012; Petersen-Lewis 2009; Goodman and Reid 2017). In natural settings, Pacific Lampreys are able to ascend even large obstacles like waterfalls (10 m vertical or greater), a skill which provides access to a range of habitats not accessible by jumping (Reid and Goodman in prep). However, their approach to passing obstacles requires smooth attachment points and rounded surfaces without acute angles, common in natural features, but not typically considered when designing dams or artificial fishways (Keefer et al., 2010). Current investigations on a 50 ft dam on the Eel River has demonstrated that Pacific Lampreys are capable of climbing a 270 ft variable-incline smooth pathway, including vertical reaches, over the dam in a matter of hours (Goodman and Reid 2017, Reid and Goodman in prep.).

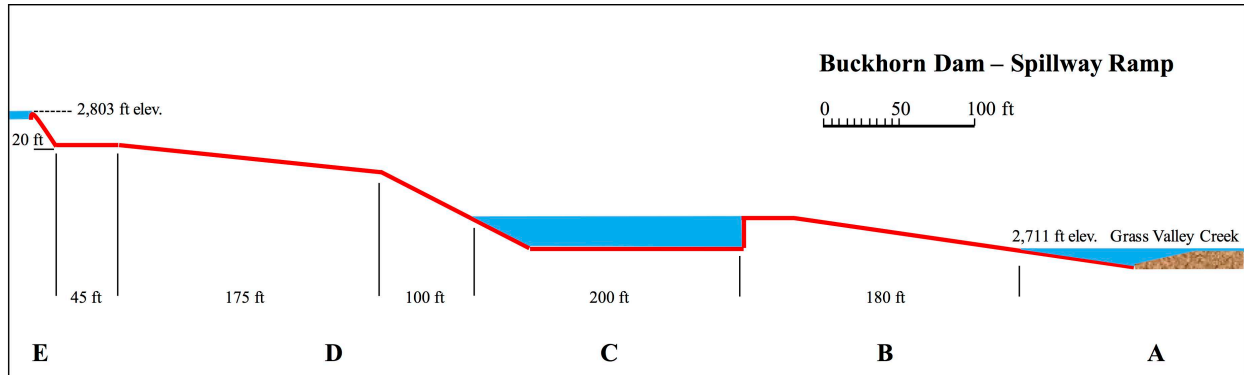
Assessment: In order to assess the feasibility of Pacific Lamprey climbing up the spillway, we climbed it conceptually from the standpoint of a lamprey, assessing whether any features represented a barrier, starting at Grass Valley Creek and the lower outflow pool (Figure 15, right side).

Figure 16. Buckhorn Spillway configuration (adapted from engineering drawing: USBR 1988).

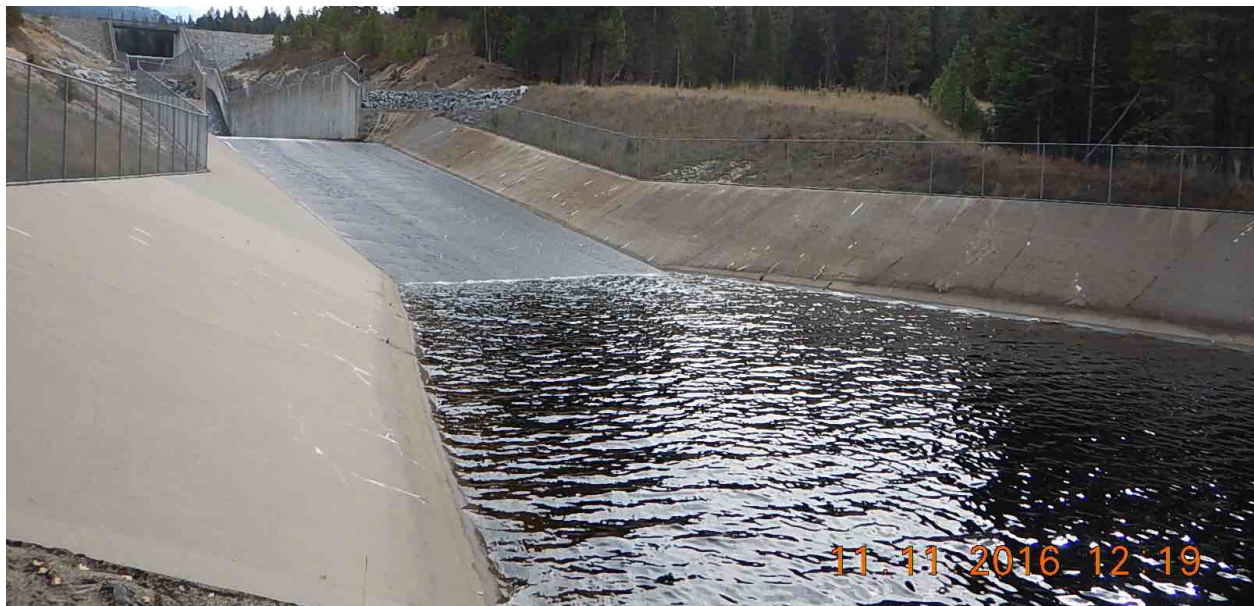
A) Grass Valley Creek and the lower outflow pool (Figure 17) - Water from the spillway exits the lower pool over an armored cobble and small boulder cascade with rock features and no angular concrete edges, similar in form to a steep natural riffle. Since Buckhorn Dam is a run-of-the-river reservoir, flows are equivalent to the creek itself, or somewhat lower depending on outflows through the outlet pipe. There are no passage constraints in this section, which has channel characteristics similar to natural features.

Figure 17. Buckhorn Spillway - Sections A and B: Entry pool and lower ramp (ramp length 180 ft, ~ 8° incline).

B) The lower ramp (Figure 17: length 180 ft, $\sim 8^\circ$ incline) - The entire ramp is smooth concrete at relatively gentle slope with minor joints (no extruding edges or impassable gaps) and has sheet flow at most overflows (photo with reservoir elev. 1803.00). There are no passage constraints in the section. Lampreys demonstrate sub-aerial climbing capability on smooth inclined surfaces of $10^\circ - 80^\circ$ with little change in performance (Keefer et al. 2011, Goodman and Reid 2017).

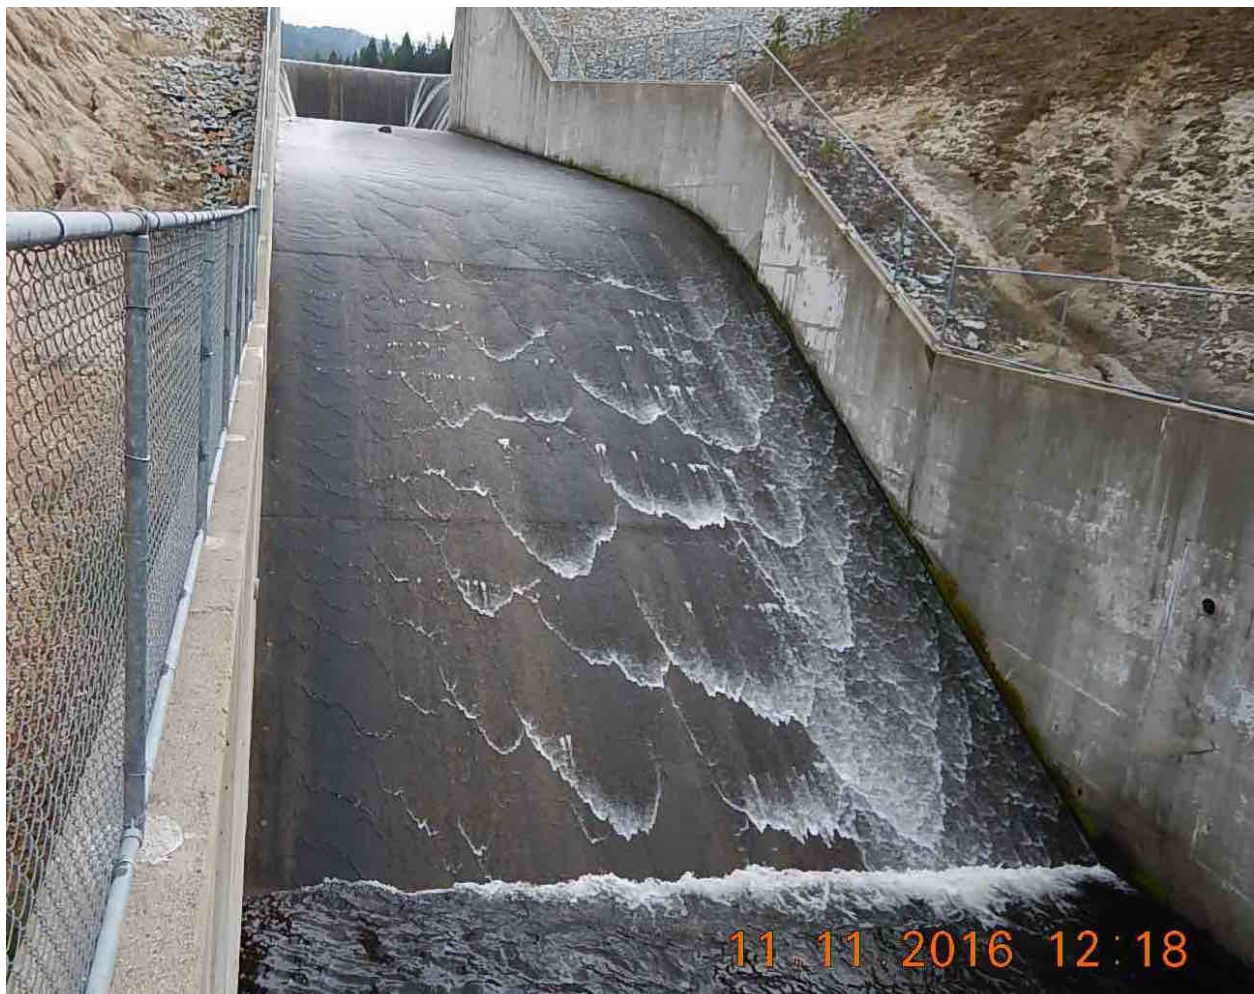
Figure 18. Buckhorn Spillway - Section D: The upper ramp (length 275 ft, $\sim 10^\circ - 45^\circ$).

D) The upper ramp (Figure 18; length 275 ft, varies from $\sim 10^\circ - 45^\circ$) - The entire ramp is smooth concrete at a variable slope with minor joints (no extruding edges or impassable gaps) and continuous sheet flow at most overflows (photo reservoir elev. 1803.00). This ramp includes

the steepest reach (100 ft long and $\sim 45^\circ$), but this is well within the capability of a climbing lamprey and in experimental settings has not been shown to substantially change climb rate. There are no passage constraints in the section. Lampreys demonstrate sub-aerial climbing capability on smooth inclined surfaces of $10^\circ - 80^\circ$ with little change in performance (Keefer et al. 2011, Goodman and Reid 2017).

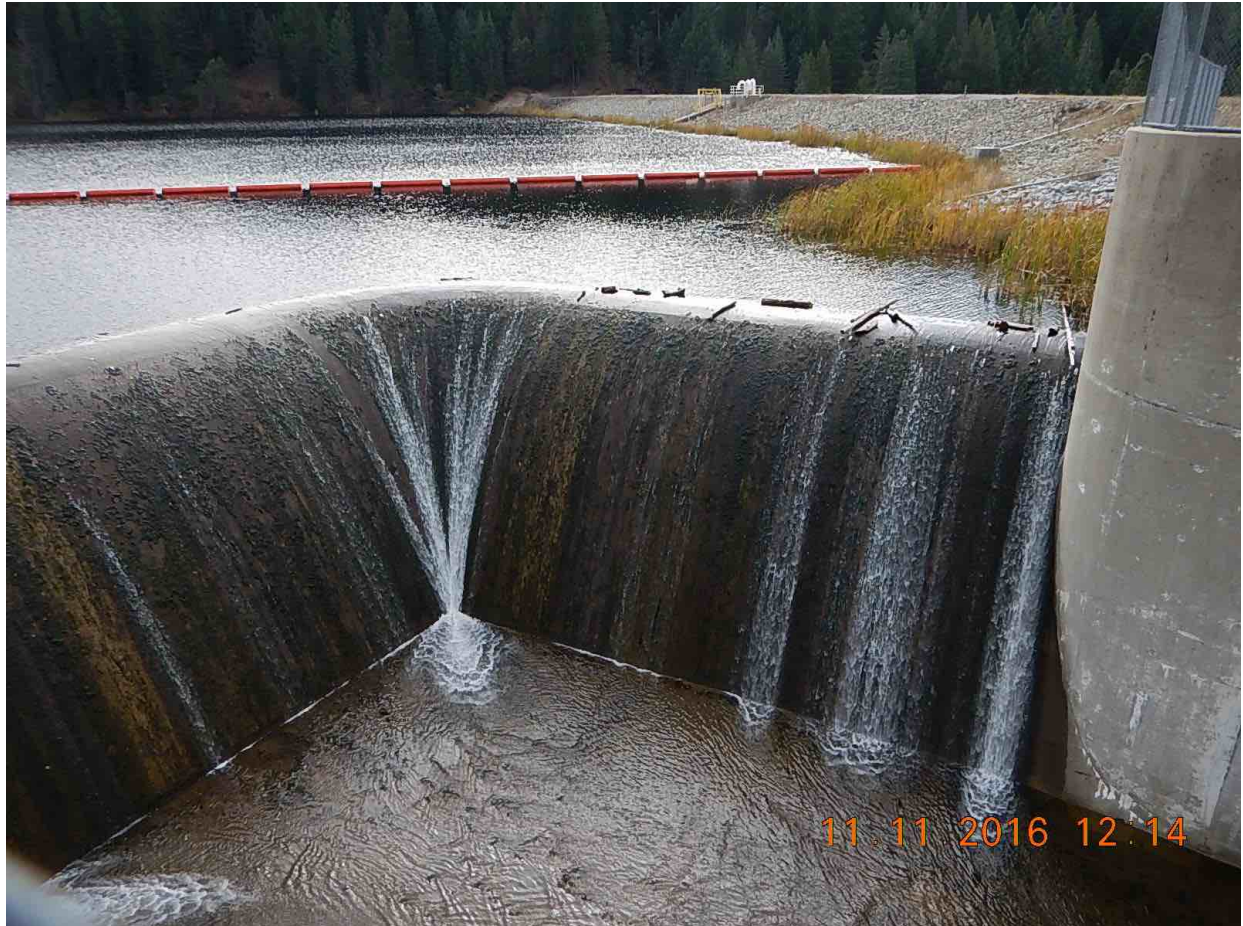
Figure 19. Buckhorn Spillway - Section E: The upper spillway wall (height 20 ft, with a slight incline; photo at reservoir elevation 2803.00 ft).

E) The upper spillway wall (Figure 19; height 20 ft, with a slight incline; photo at reservoir elevation 2803.00 ft) - This is the final challenge for a Pacific Lamprey climbing the spillway. It is 20 ft tall, but unlike many man-made features, the Buckhorn Spillway includes a number of features making it particularly suitable to lamprey passage. 1) At most spill conditions, the long axis of the crest (150 ft) reduces flow to a relatively thin sheet flow and reduces flow velocities. 2) The sheet flow provides a continuous wetted vertical surface without high velocities likely to dislodge a climbing lamprey. 3) The concrete surface is smooth and provides an excellent attachment surface for suctorial climbing. 4) The top of the wall is broadly rounded, allowing a lamprey to continue climbing without encountering an acute edge, which could block movement or break suction. 5) The crest is of sufficient diameter that propulsion vectors (from body and

tail) are generally aligned with direction of movement - unlike with a narrow diameter obstacle that requires a lamprey to change directions in order to dive for the bottom. 6) The rounded crest extends over the top and down on the reservoir side, providing a continuous attachment route into the refuge of low energy water below the outflow current. 7) The nature of the spillway is such that there are multiple paths up the wall with variable flow conditions and velocities. 8) Even in higher flow conditions, there will be a smooth, low-velocity wetted pathway up the end wall where the spillway meets the dam.

Were Pacific Lamprey to pass the dam and spawn upstream, outmigrating juvenile lampreys would be likely to move over the spillway during high flow events. The drop onto the concrete apron at the base of the wall represents a possible threat of injury. In nature, lampreys frequently move downstream over falls; however, the flow is typically into a deep plunge pool at the base, which reduces impact risks. Were lampreys to colonize Grass Valley Creek upstream of the dam, some form of water retention structure on the upper apron might be considered in order to form a shallow cushioning pool.

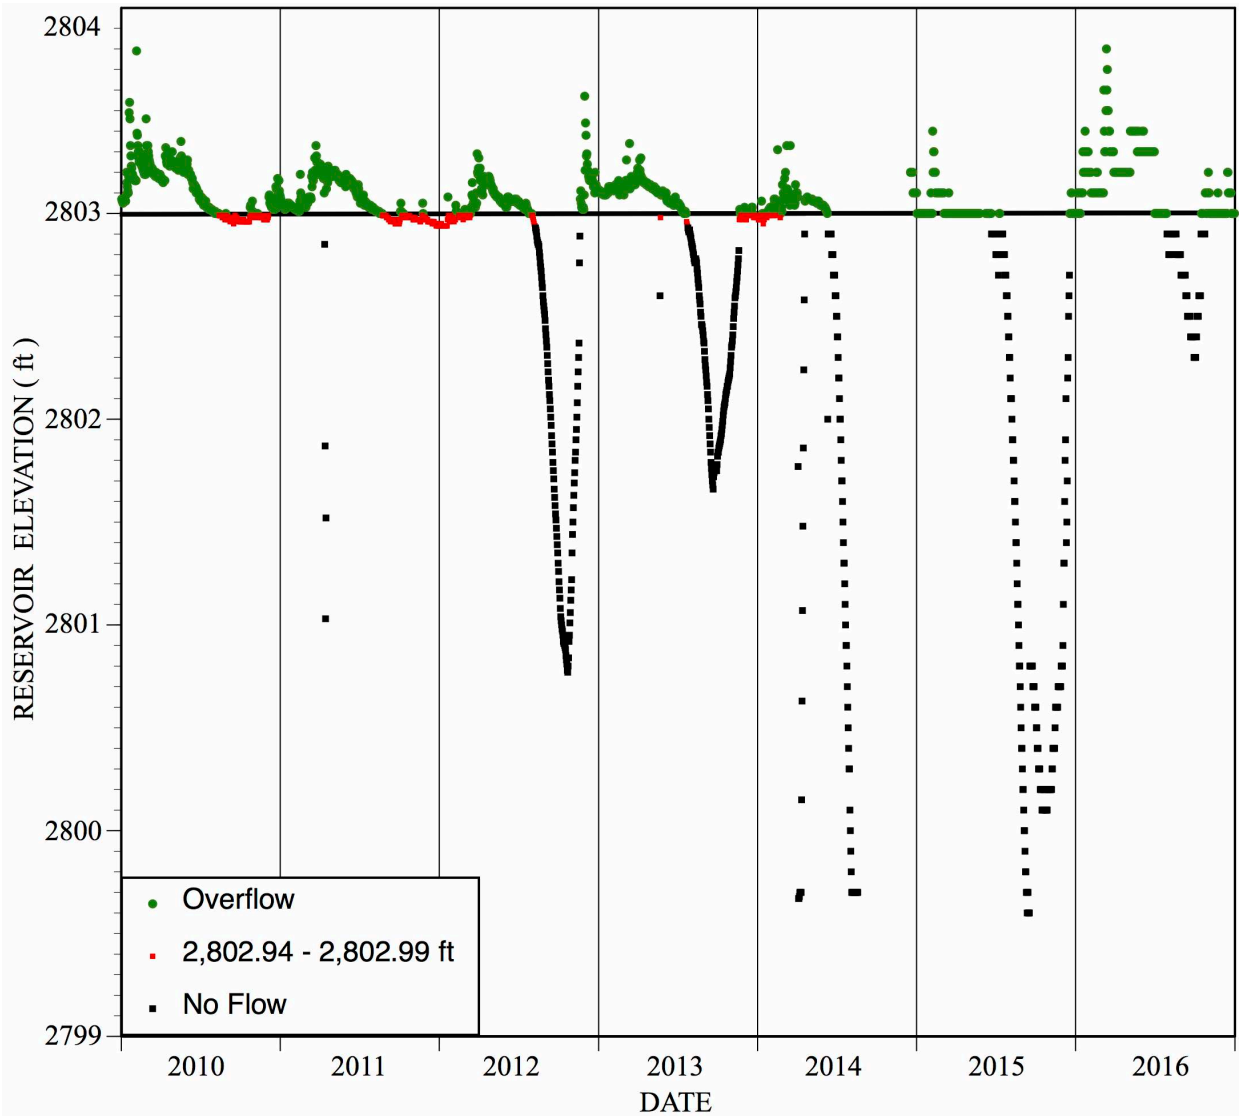
Flow management considerations: The Buckhorn spillway is only passable at times of overflow, lampreys can't climb dry surfaces, and when flows down the ramp are relatively shallow (Figure 20). During high flow events when water depth and velocities down the ramps exceed burst-attach locomotion or require extreme effort, lampreys are also unlikely to climb the ramp. However, they may be able to follow the water surface along the wetted vertical sidewalls. The critical swimming speed for Pacific Lamprey is near 0.85 m/s (Mesa et al. 2003). However, they can pass higher velocities over a short distance using burst and attach locomotion. Nevertheless, the limit for successful passage of even a short distance is apparently near 2.5 m/s (Keefer et al. 2010). The considerable length of the Buckhorn Spillway represents a substantial challenge even under ideal conditions. Therefore, optimum opportunities for passage will be when the spillway is providing shallow sheet flow and relatively low boundary velocities, ideally with water depths less than the thickness of an adult lamprey (~ 0.13 ft).

- 0.13 ft of spillway elevation 60% of the time (714/1199 daily records)
- 0.20 ft of spillway elevation 82% of the time (984/1199)
- 0.30 ft of spillway elevation 96% of the time (1149/1199)

Figure 20. Buckhorn Reservoir elevation, 1 January 2010 - 31 December 2016. Spill down ramp occurs at design elevation of 2,803.00 ft and above (green). However, the record suggests that spill may also be occurring from gauge levels of 2,802.94 ft up (shown in red). Source: http://cdec.water.ca.gov/cgi-progs/stationInfo?station_id=GVO. Note that considerable water was already flowing over the spillway at a gauge reading of exactly 2,803.00 (Figure 18).

Discussion: The overflow spillway ramp at Buckhorn Dam presents no impassable features for adult Pacific Lamprey, although it represents a substantial challenge even under ideal conditions, due to its height and length. The spillway ramps are at angles that Pacific Lamprey are able to climb under sheet-flow conditions. The final wall at the top of the ramp (20 ft) represents a climbing challenge. However, Pacific Lamprey are known to pass 30 ft smooth vertical granite waterfalls, and the wall itself is not vertical but somewhat inclined. The deep entry and intermediate pool provide resting refuges. Optimum opportunities for passage occur when the spillway is providing shallow sheet-flow and relatively low boundary velocities, ideally with water depths less than the thickness of an adult lamprey (~ 0.13 ft). Management of reservoir outflows should insure that there is some flow over the spillway at least thru June, if not year round, and that periods of shallow spills are maximized (reservoir elev. 2,803.0 - 2,803.15 ft).
