SOUTH FORK TRINITY RIVER WATER QUALITY MONITORING PROJECT

Agreement No. 01-412-250-0 Draft Final Report

**Trinity County Resource Conservation District
P.O. Box 1450
Weaverville, CA 96093
(530) 623-6004**

August 2003

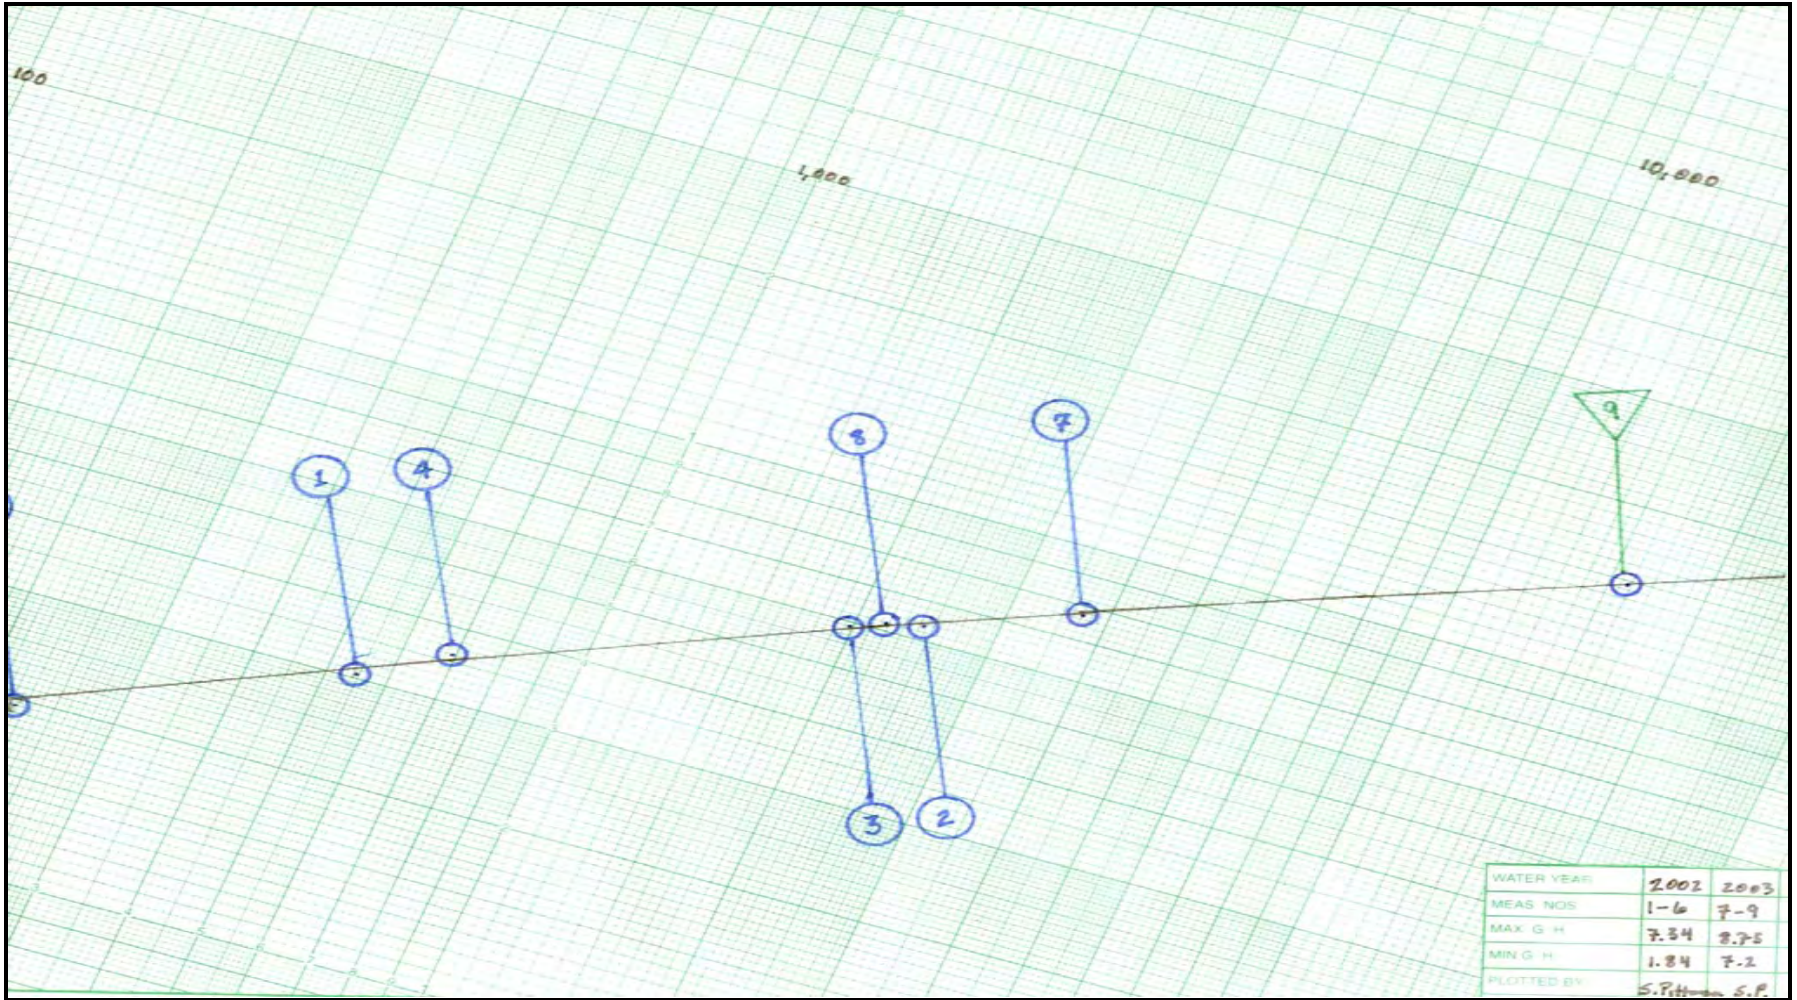
Example of hand-drawn Discharge Rating Curve: Hayfork Creek near Hyampom. Circles indicate direct discharge measurements (meter), triangles indicate indirect discharge measurements (slope-area method).

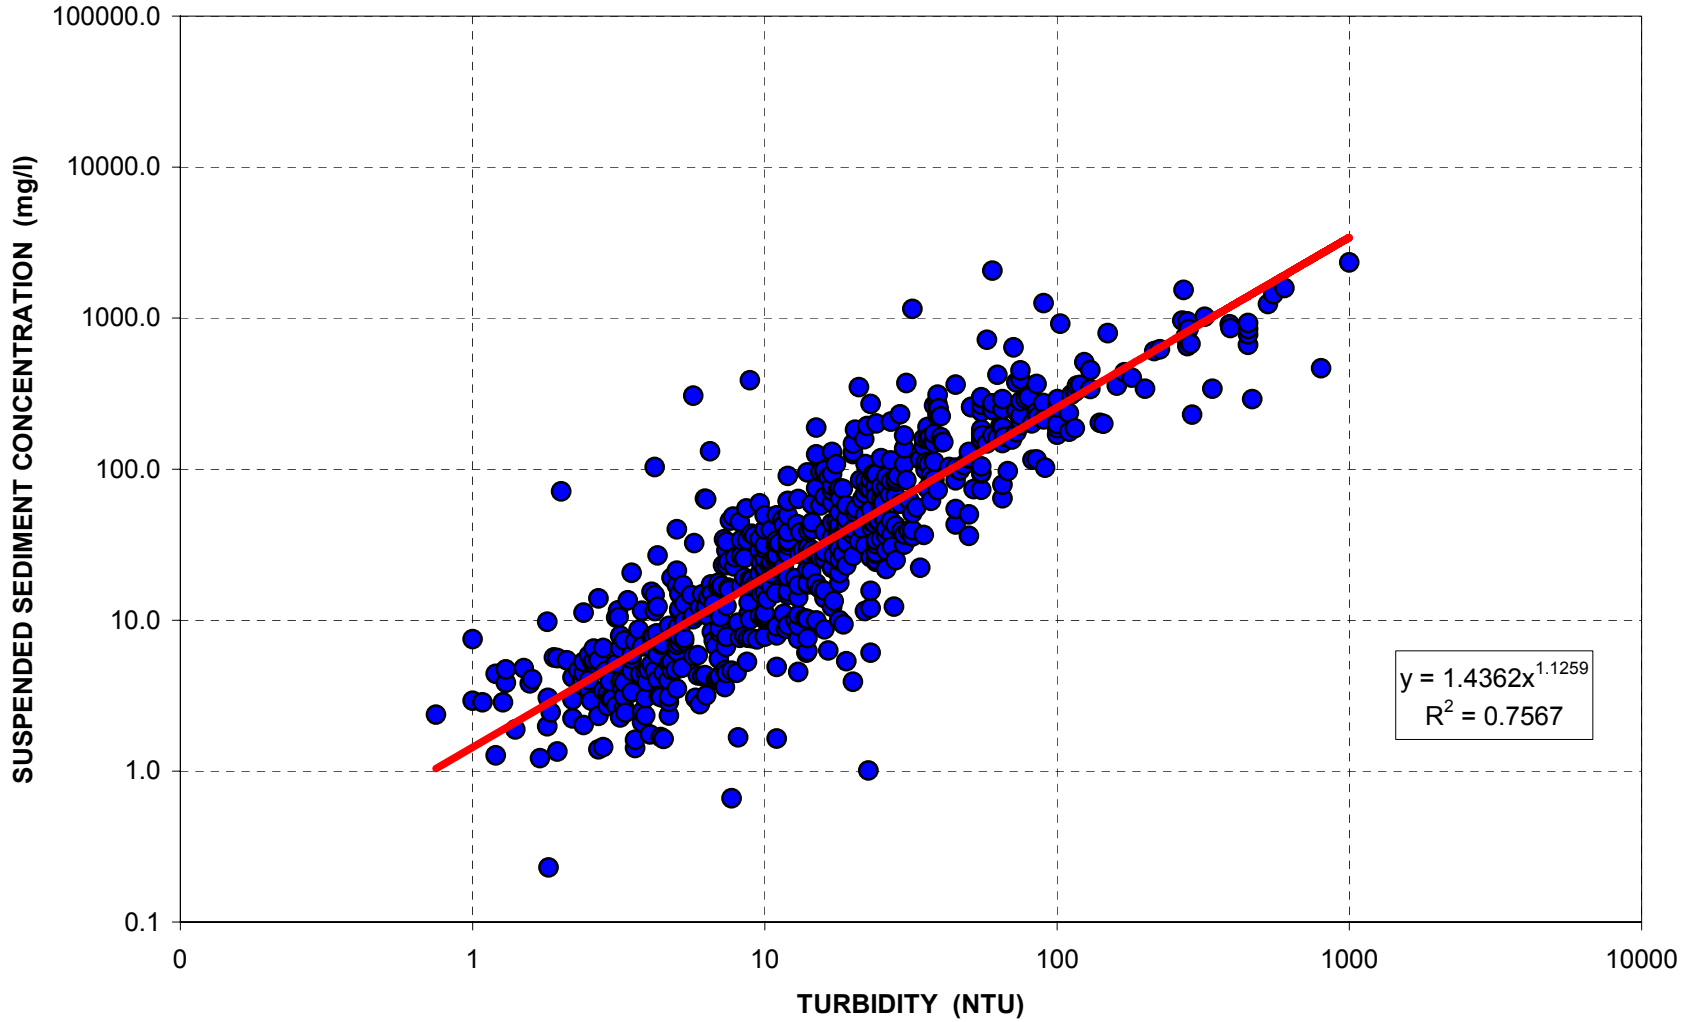
Suspended Sediment Concentration vs Turbidity, All WY2001-2003 Data

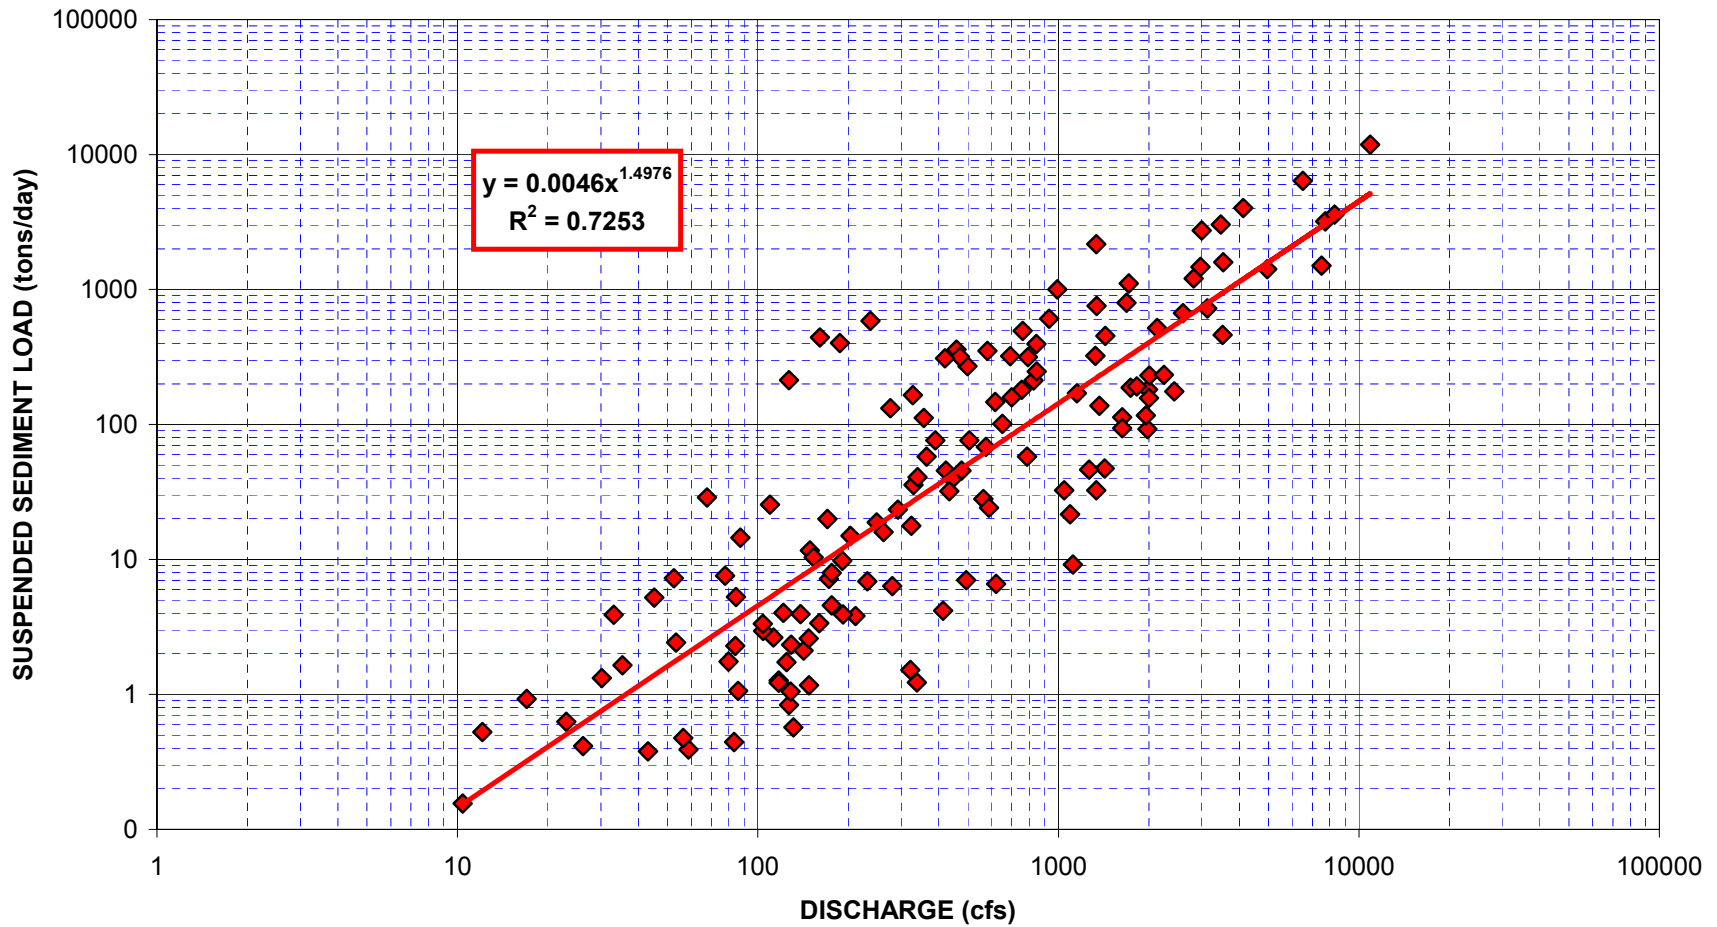
Suspended Sediment Load vs. Discharge Rating Curve, WY2001 - WY 2003, 10 Datalogger Sites Combined

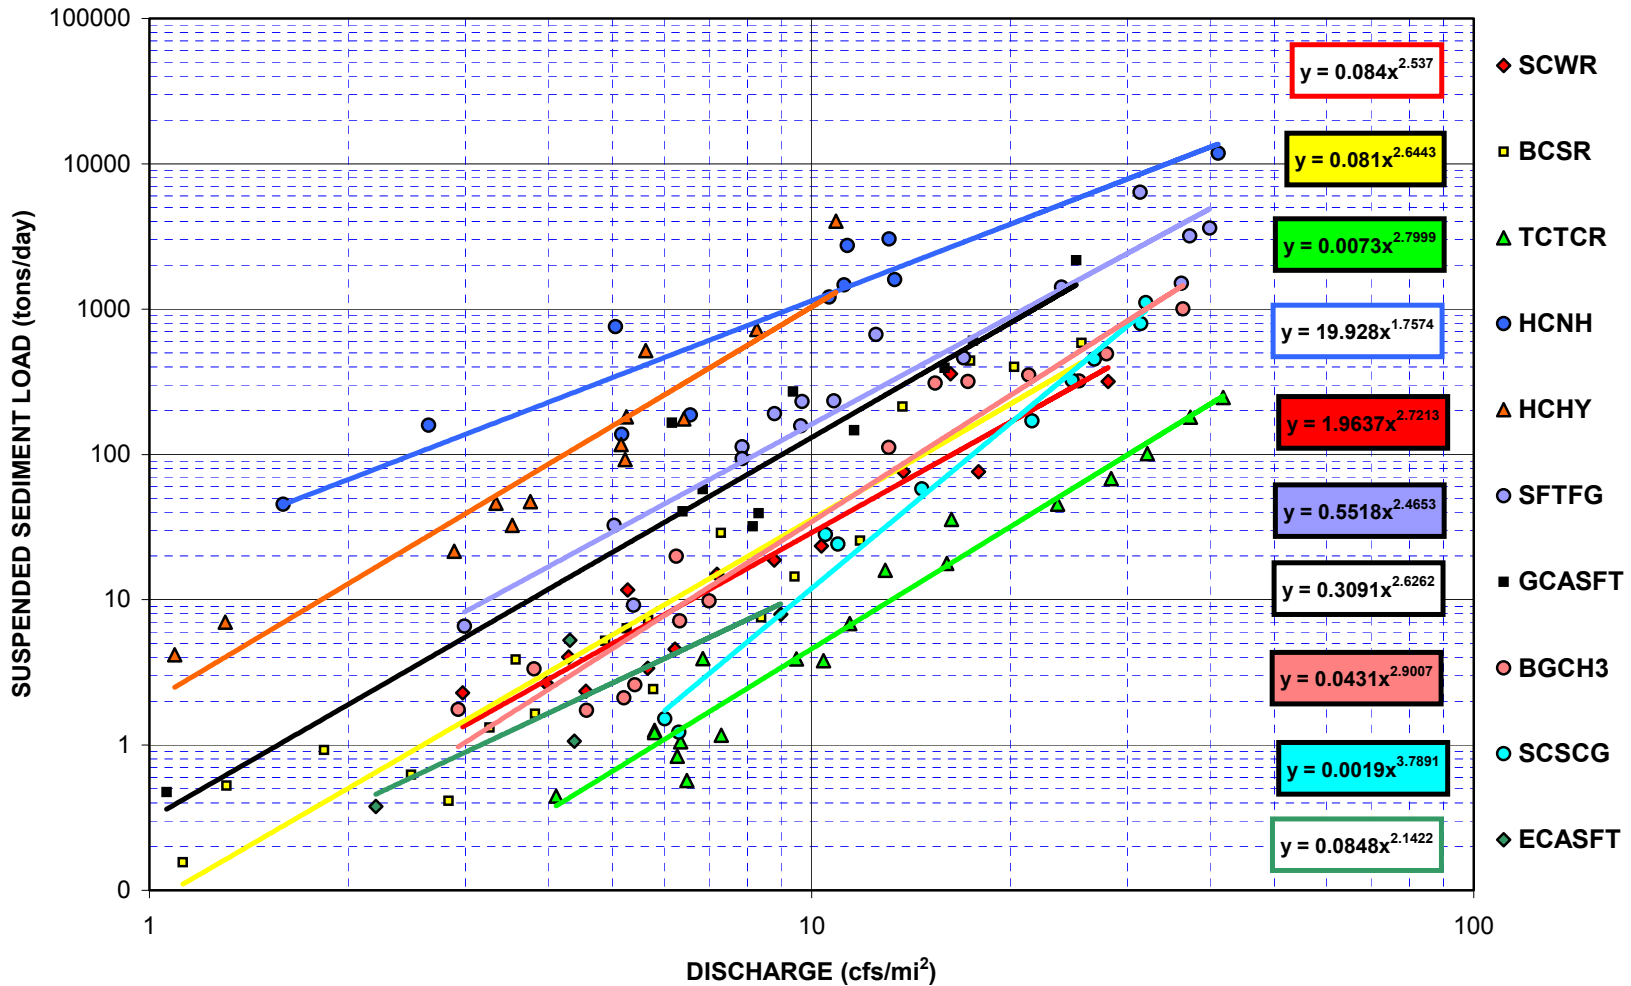
Suspended Sediment Load vs. Discharge per Watershed Area For 10 Datalogger Stations, WY2001 - WY 2003

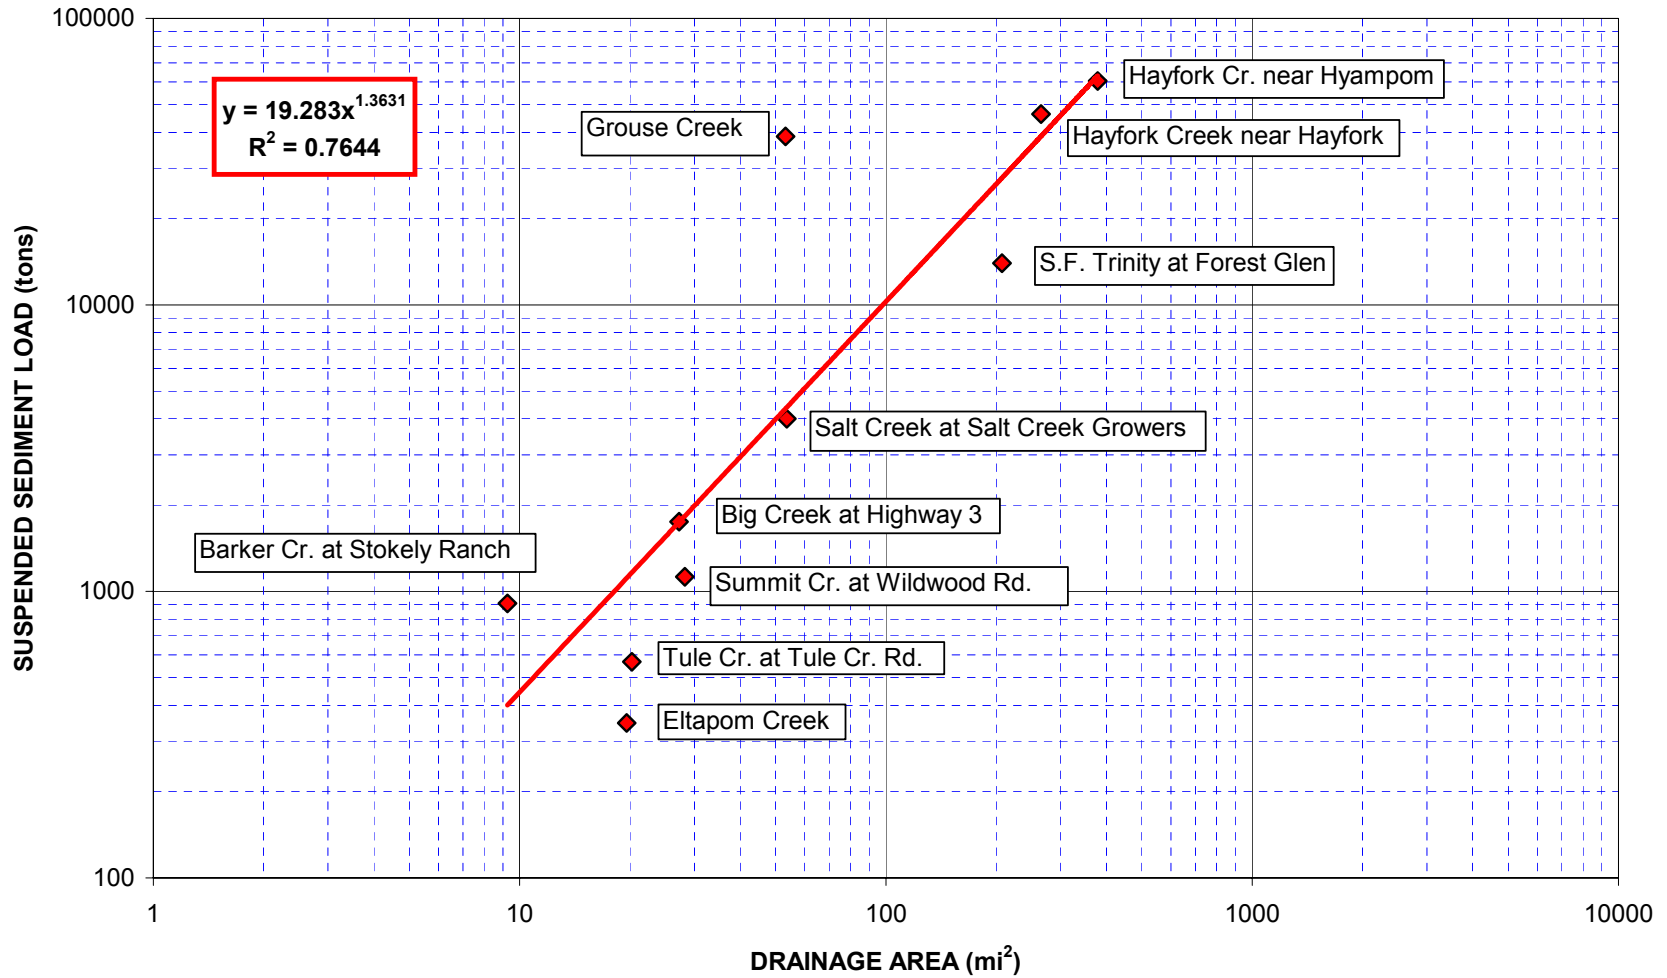
Total Suspended Sediment Load vs. Drainage Area, WY 2003, 10 Datalogger Sites

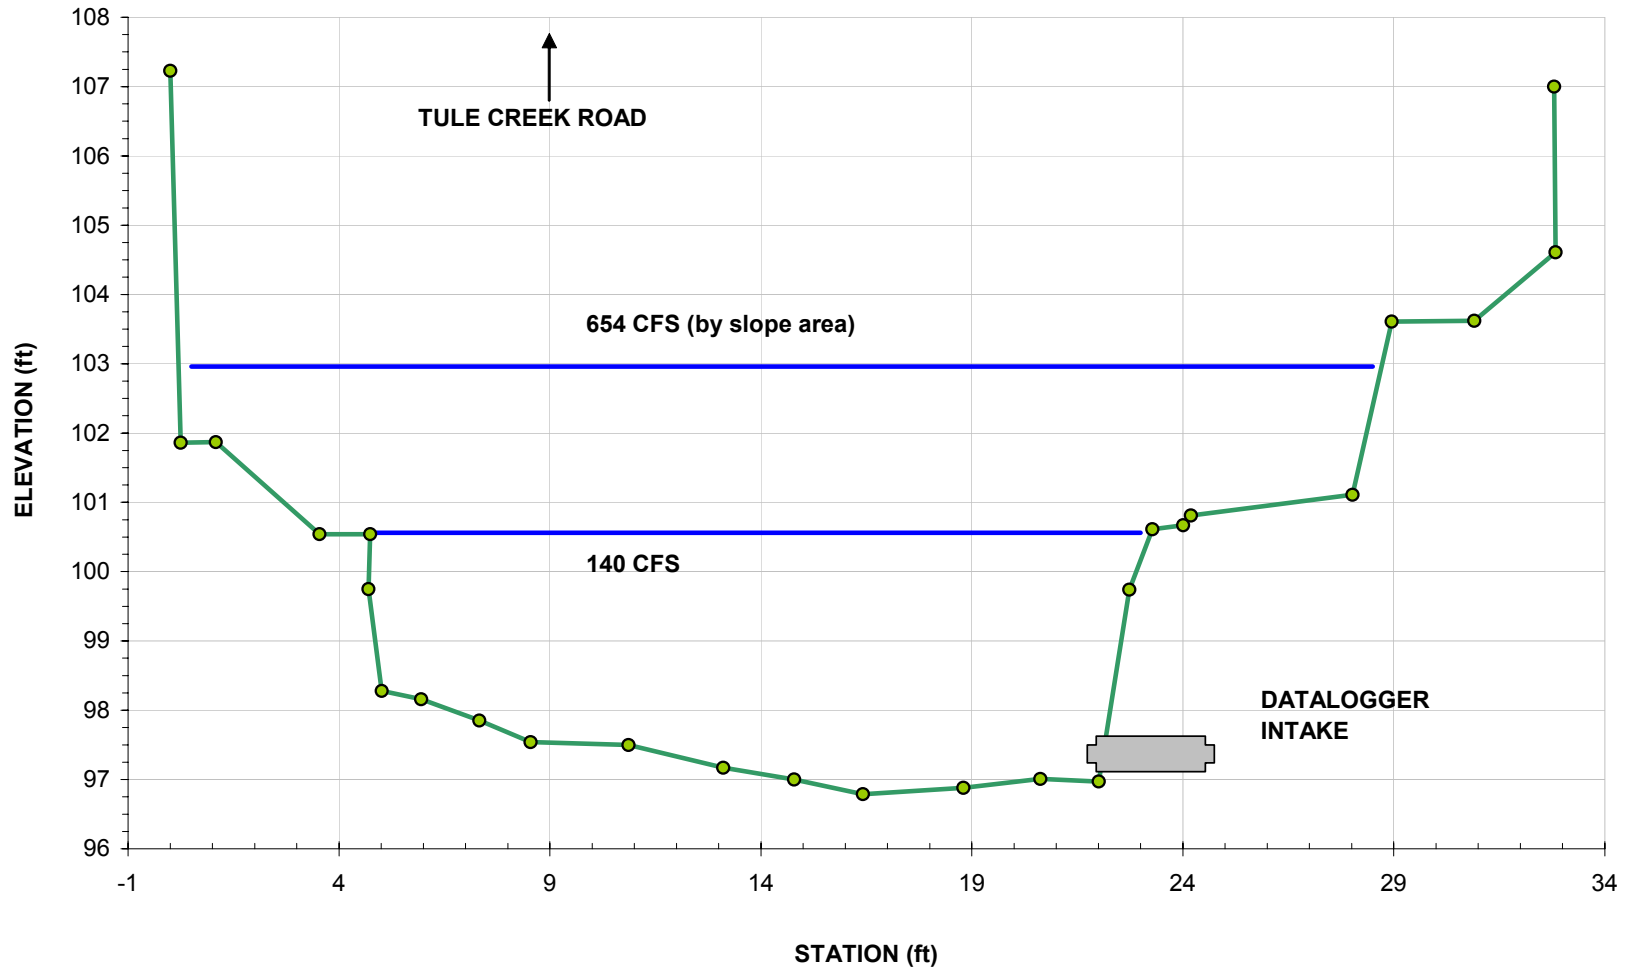
Slope Area Cross Section 1 -- 5/10/03

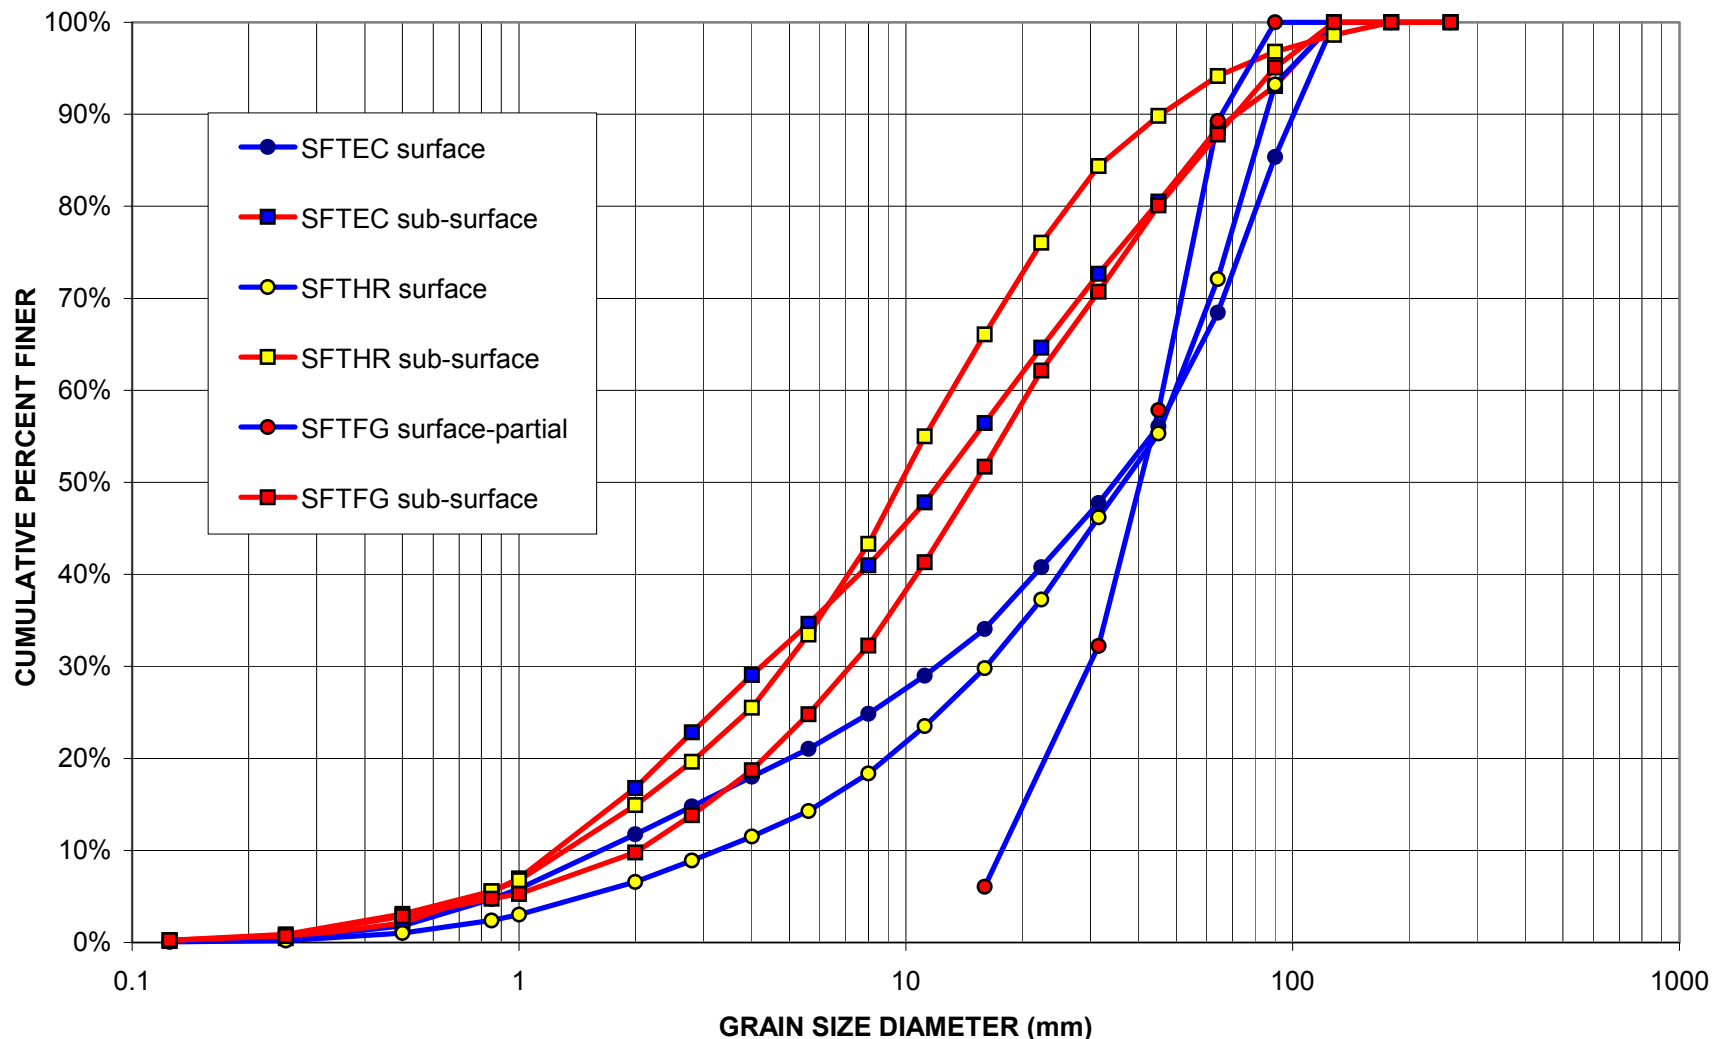
Sieve-Analyzed Cumulative Particle Size Distributions

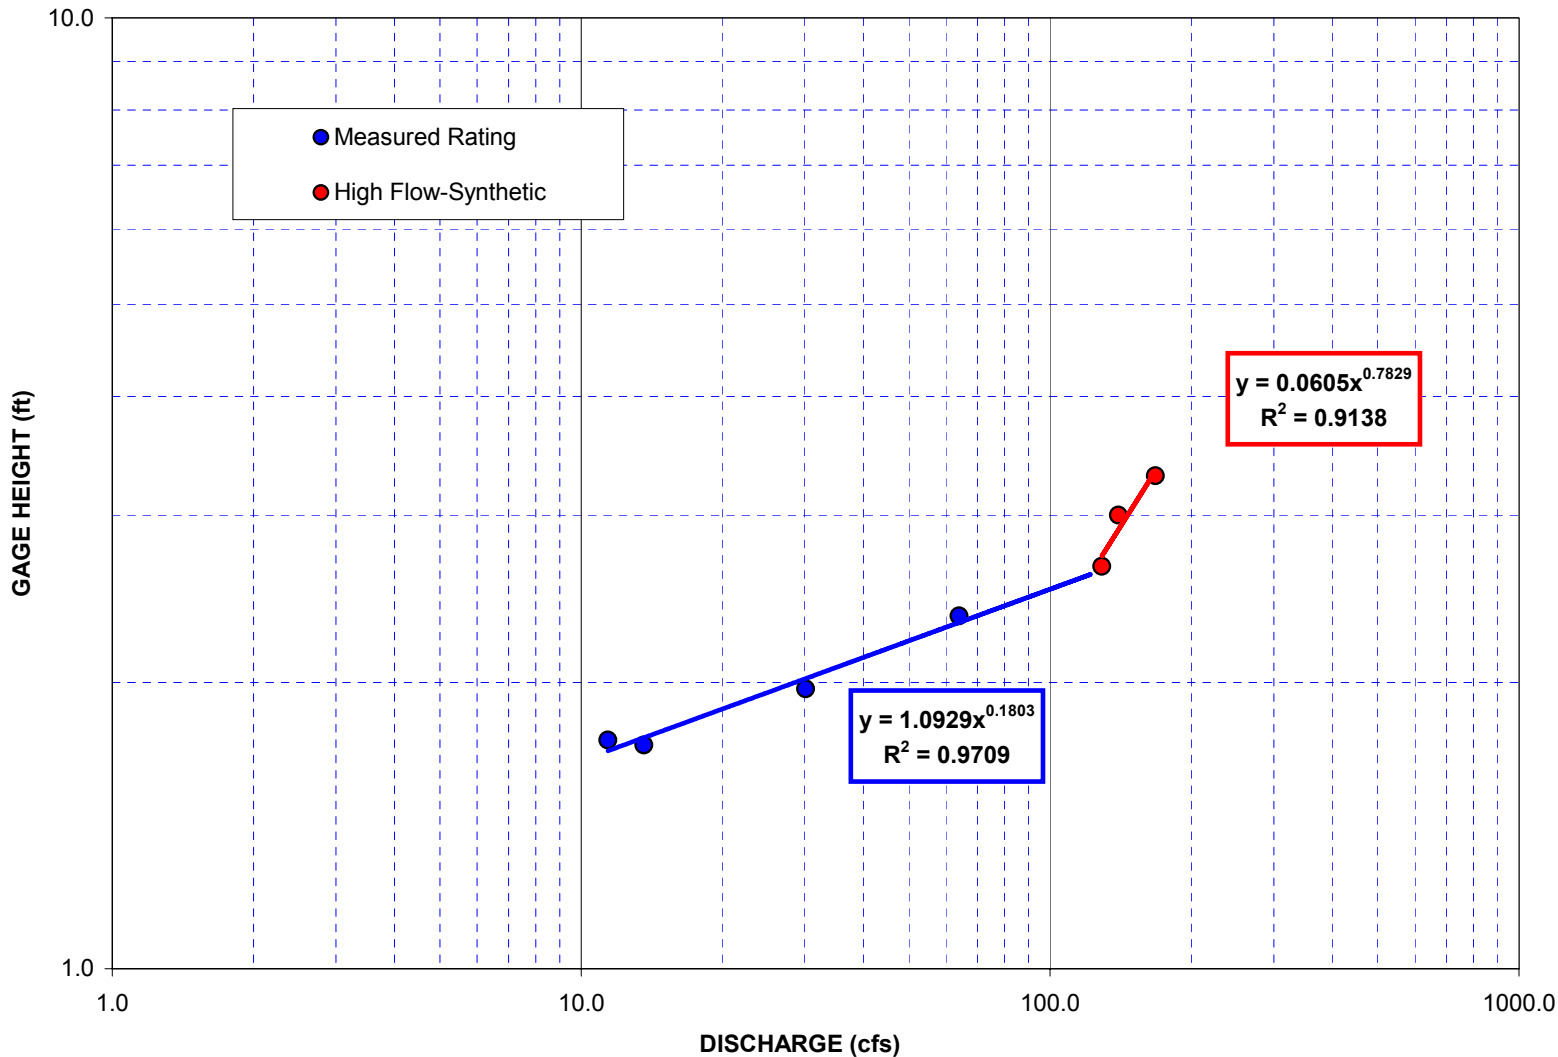
BARKER CREEK AT HIGHWAY 3
 Discharge Rating Curve -- Begin Date 2/09/01

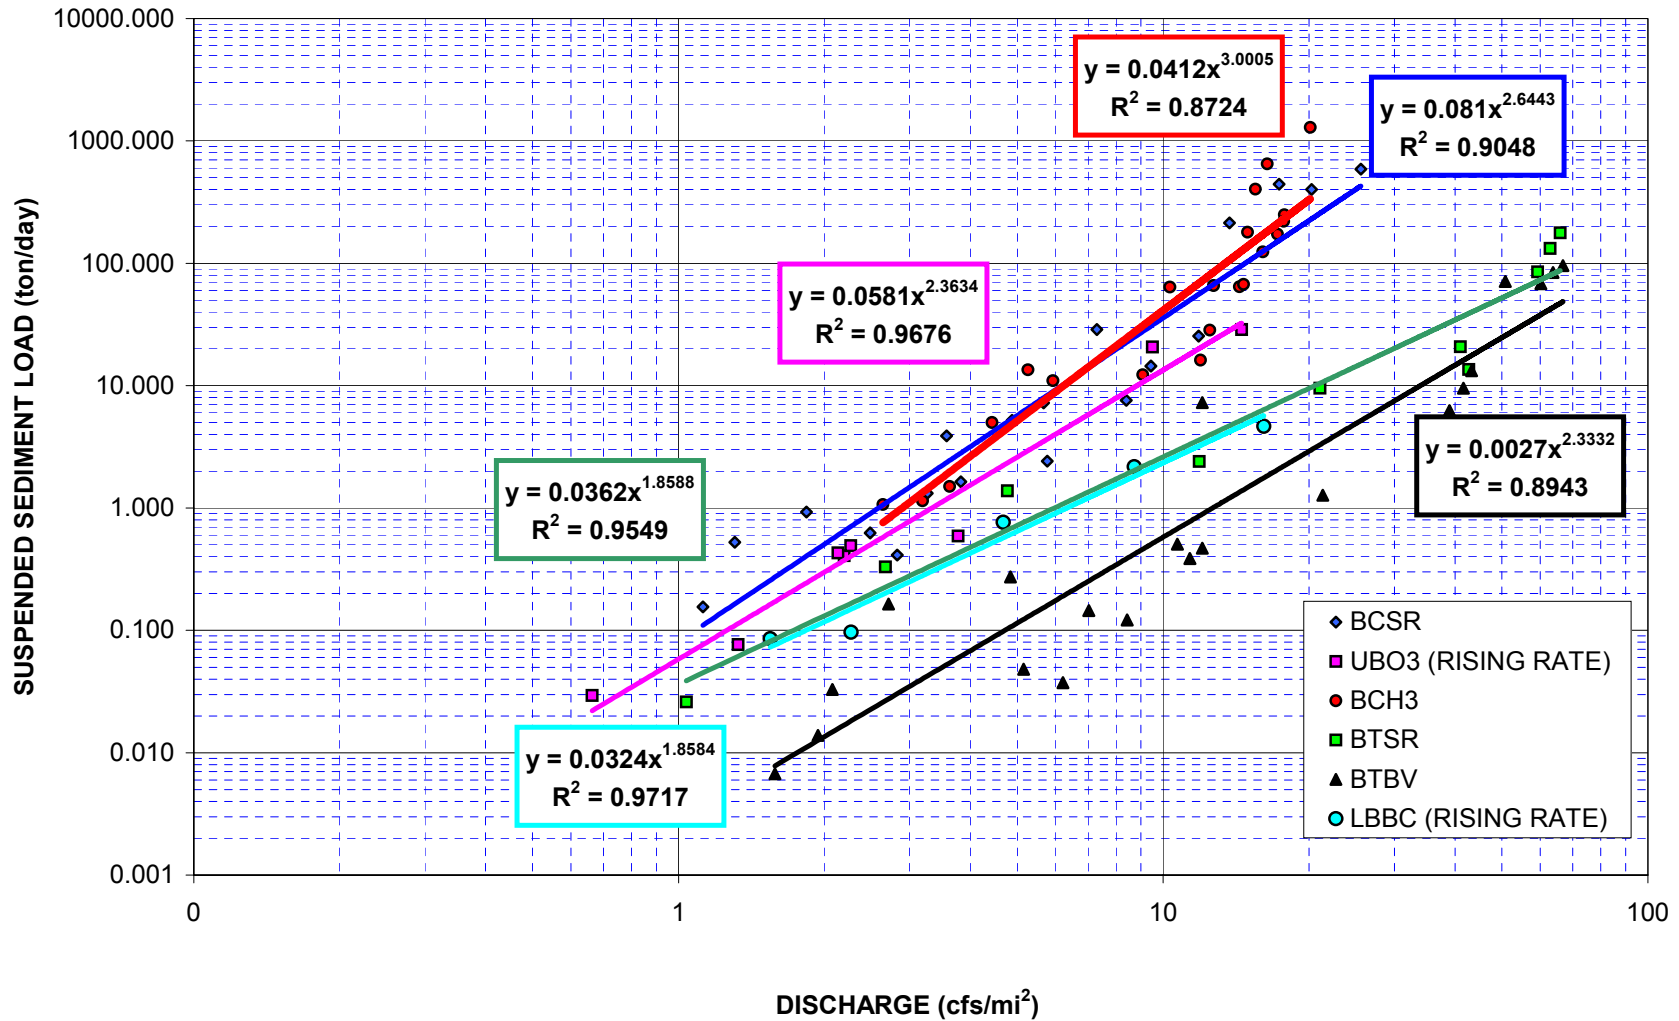
Suspended Sediment Load vs. Discharge (per watershed area)
Begin Date: 11/17/01

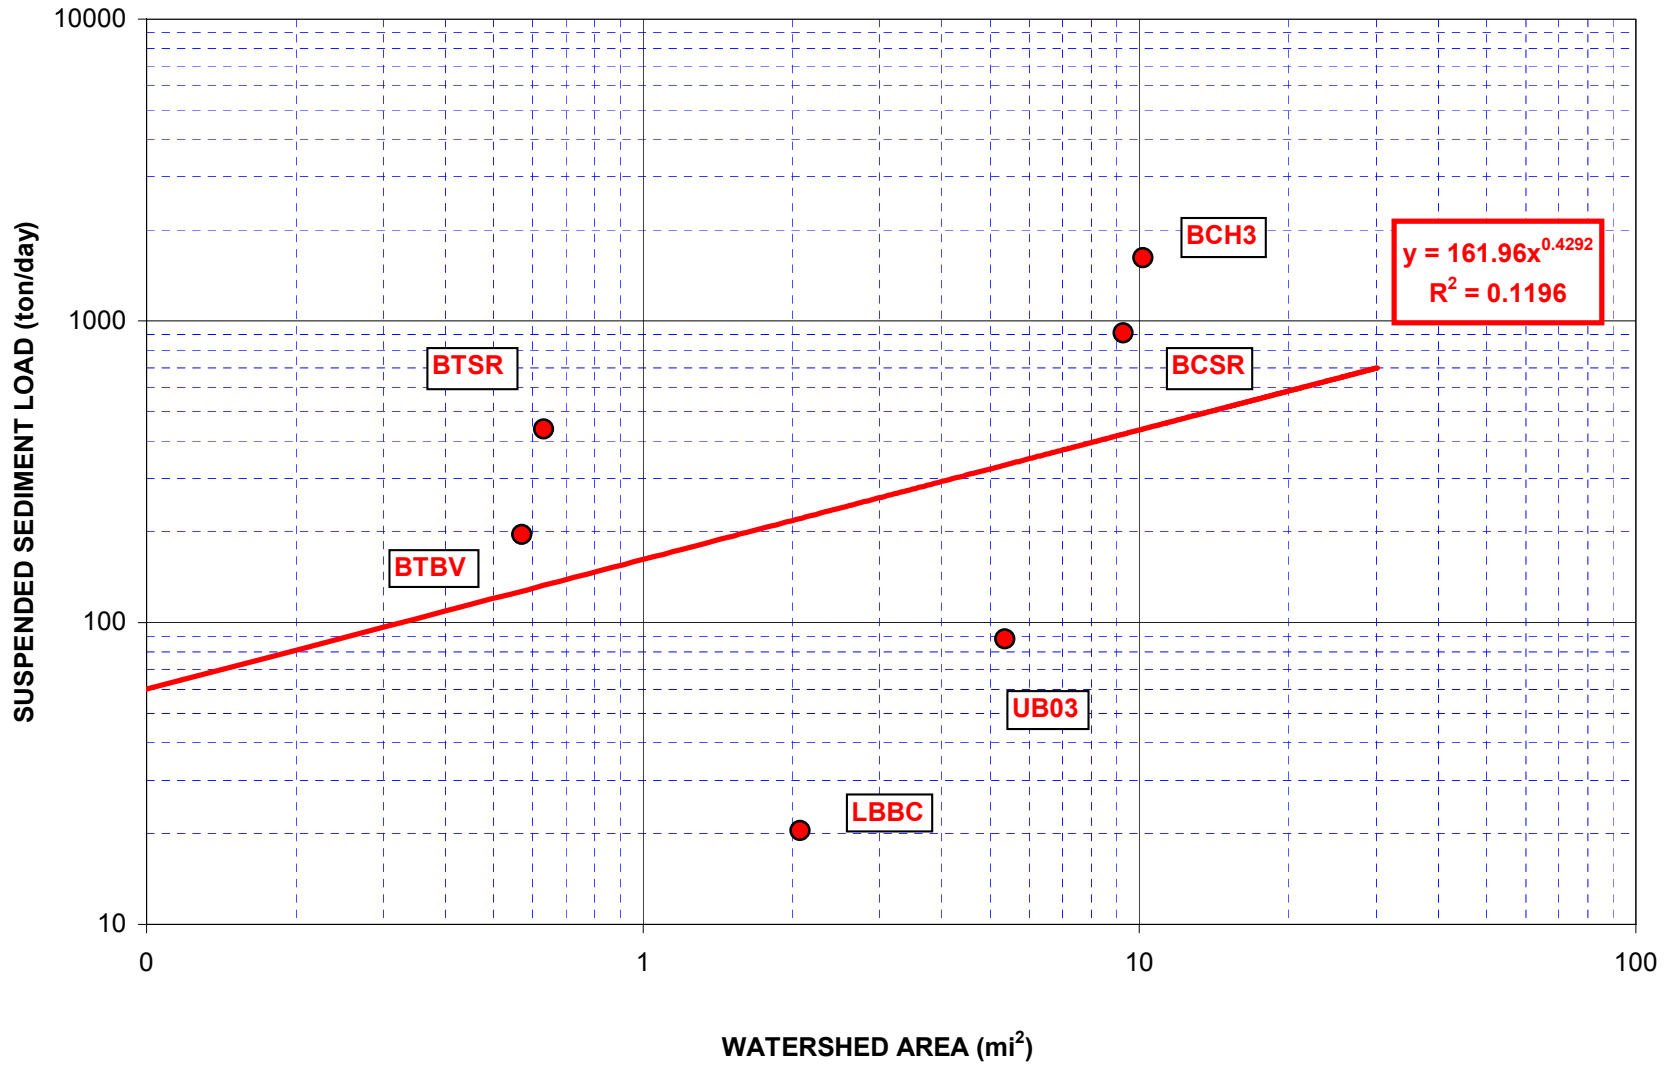
WY 2002-03 (averaged) SUSPENDED SEDIMENT LOAD vs. DRAINAGE AREA

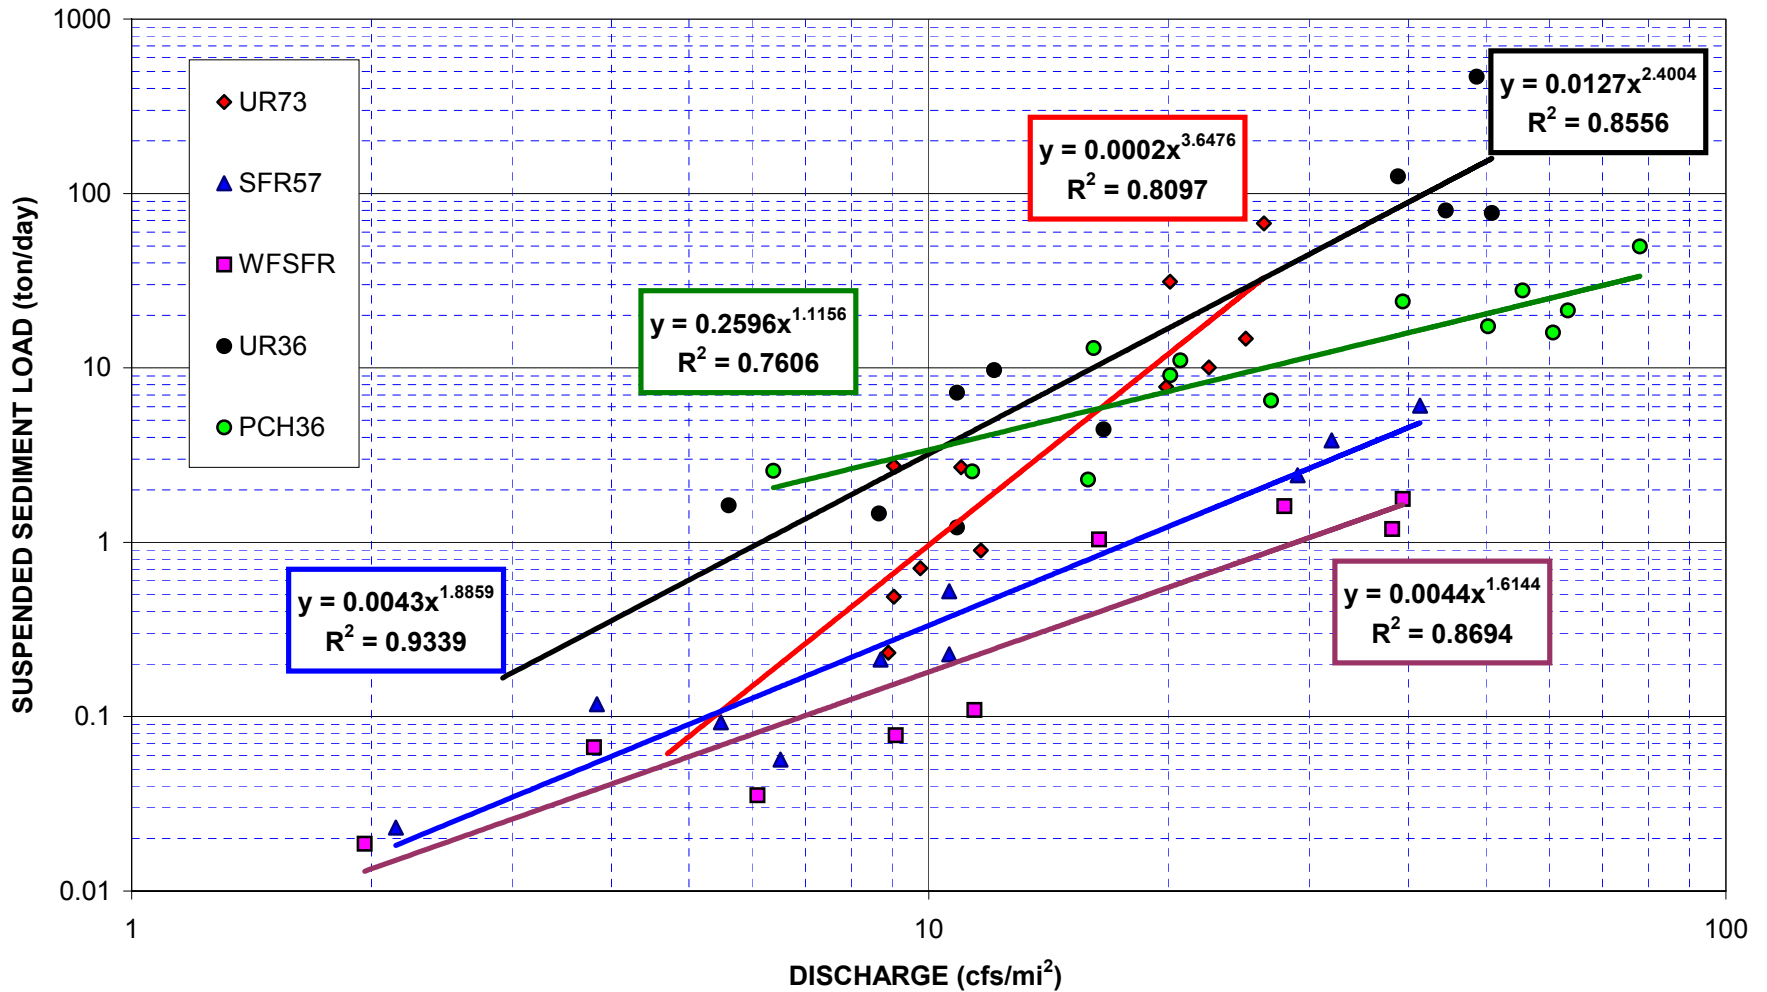
Suspended Sediment Load vs. Discharge per Watershed Area Curves -- WY 2002-2003

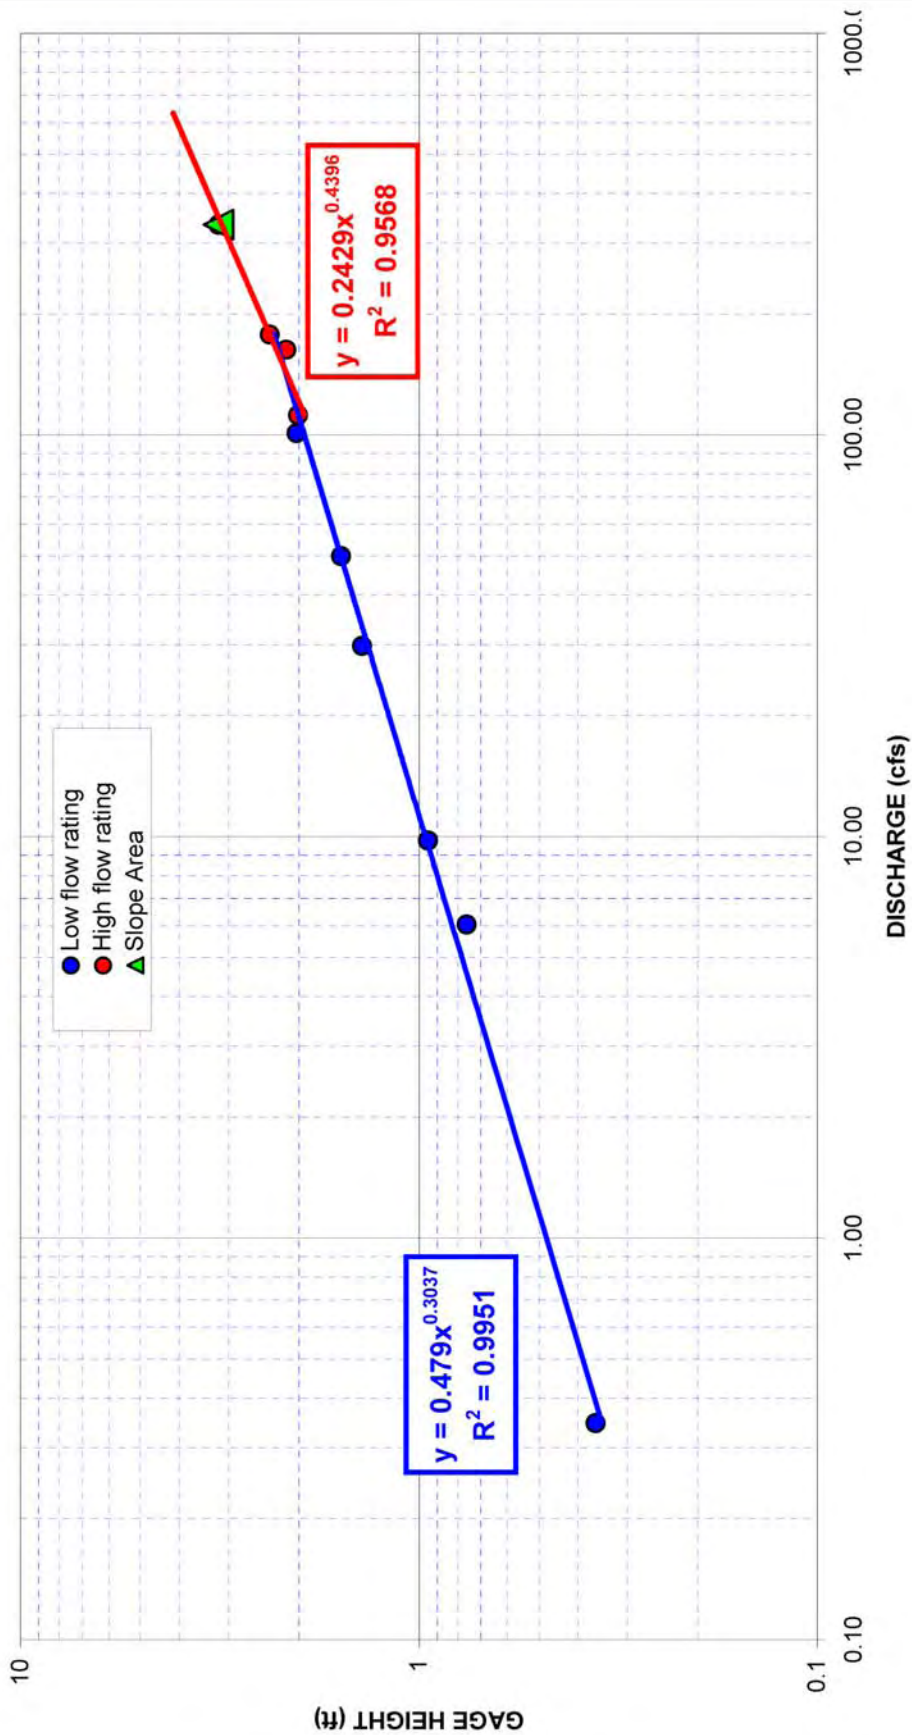
SUMMIT CREEK AT WILDWOOD ROAD
 Discharge Rating Curve -- Begin Date 2/08/01

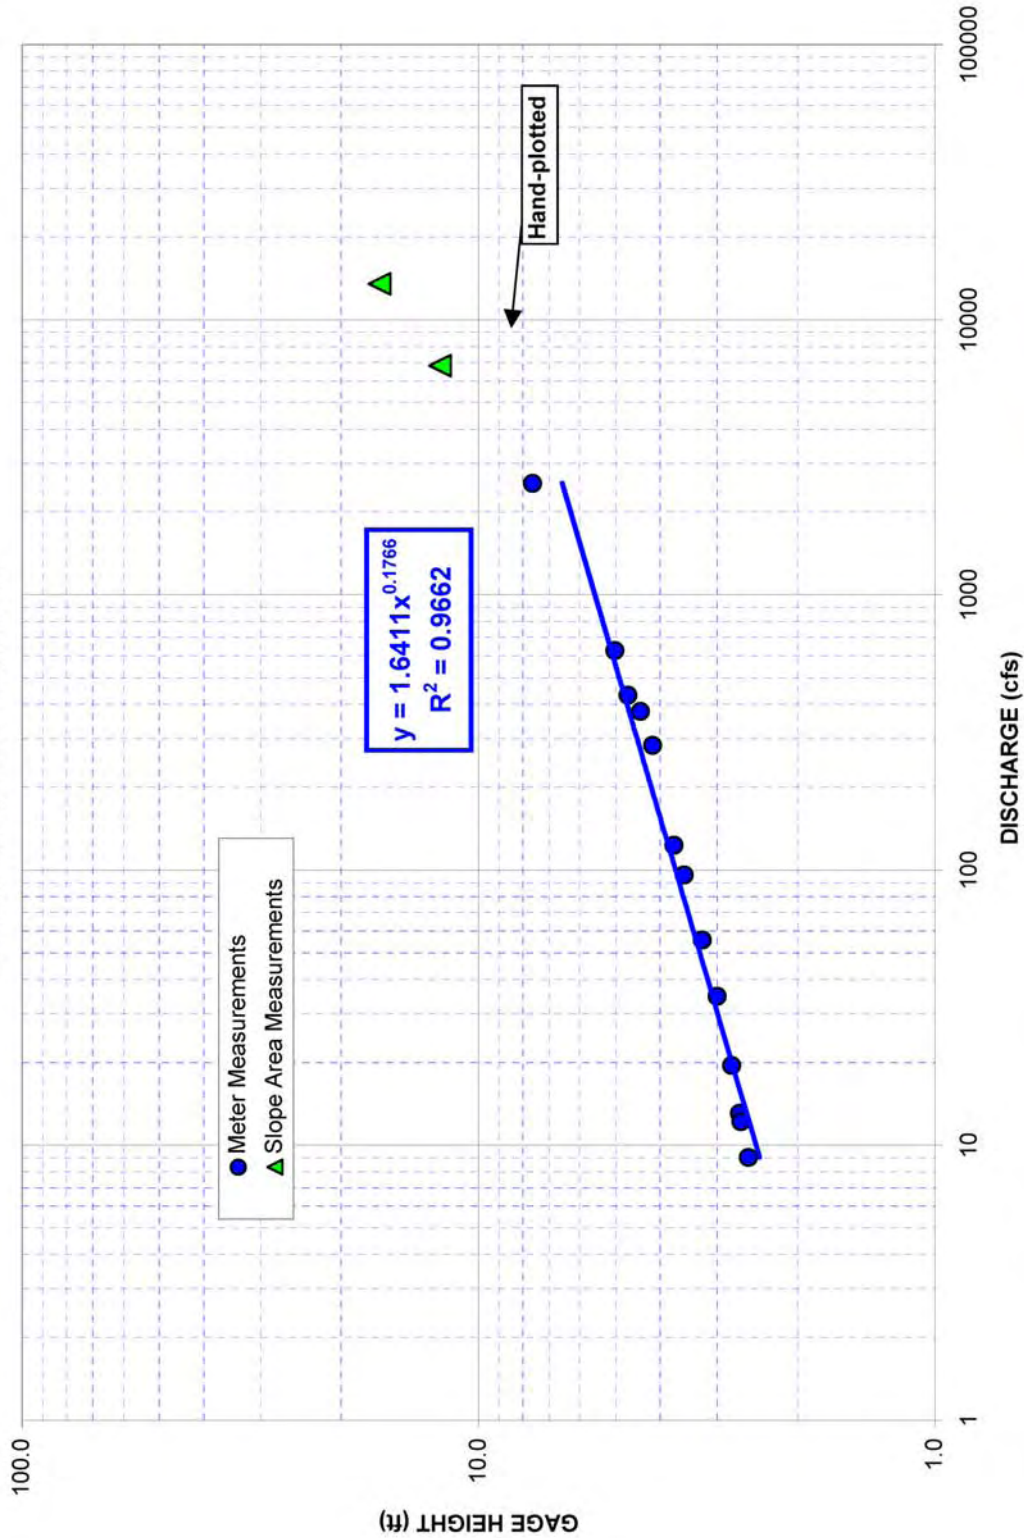
HAYFORK CREEK NEAR HAYFORK
Discharge Rating Curve -- Begin 6/10/99
