SOUTH FORK TRINITY RIVER WATER QUALITY MONITORING PROJECT

Agreement No. 01-412-250-0 Draft Final Report

**Trinity County Resource Conservation District
P.O. Box 1450
Weaverville, CA 96093
(530) 623-6004**

August 2003

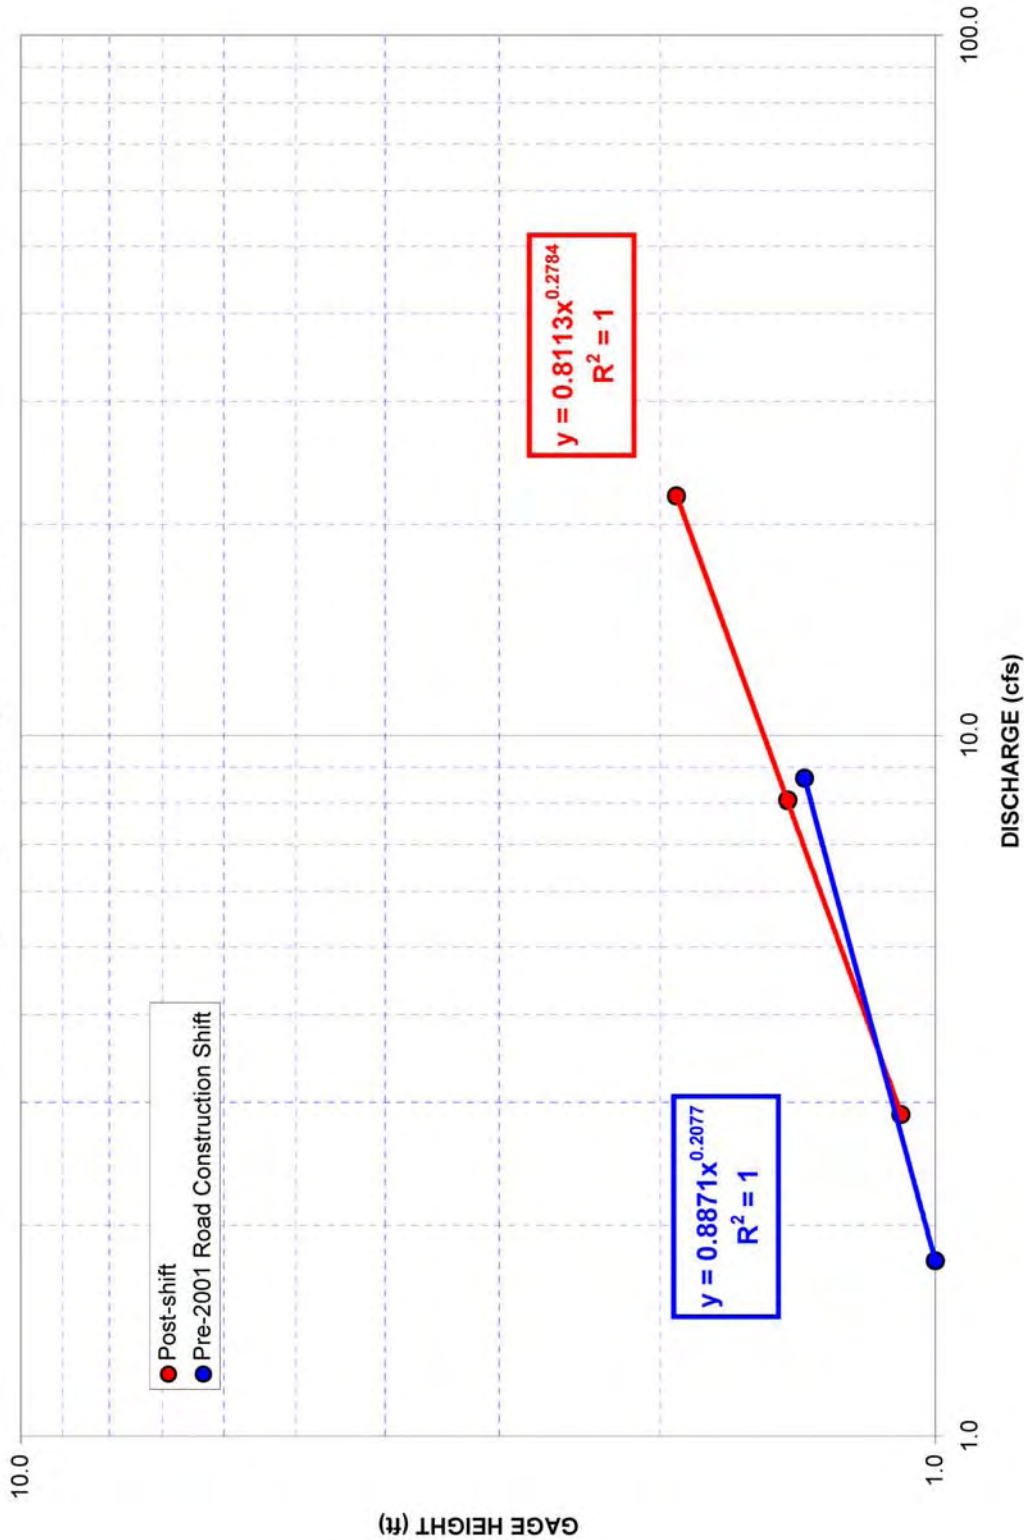
OLSEN CREEK AT OLSEN CREEK ROAD
 Discharge Rating Curve -- Begin Date 2/10/01

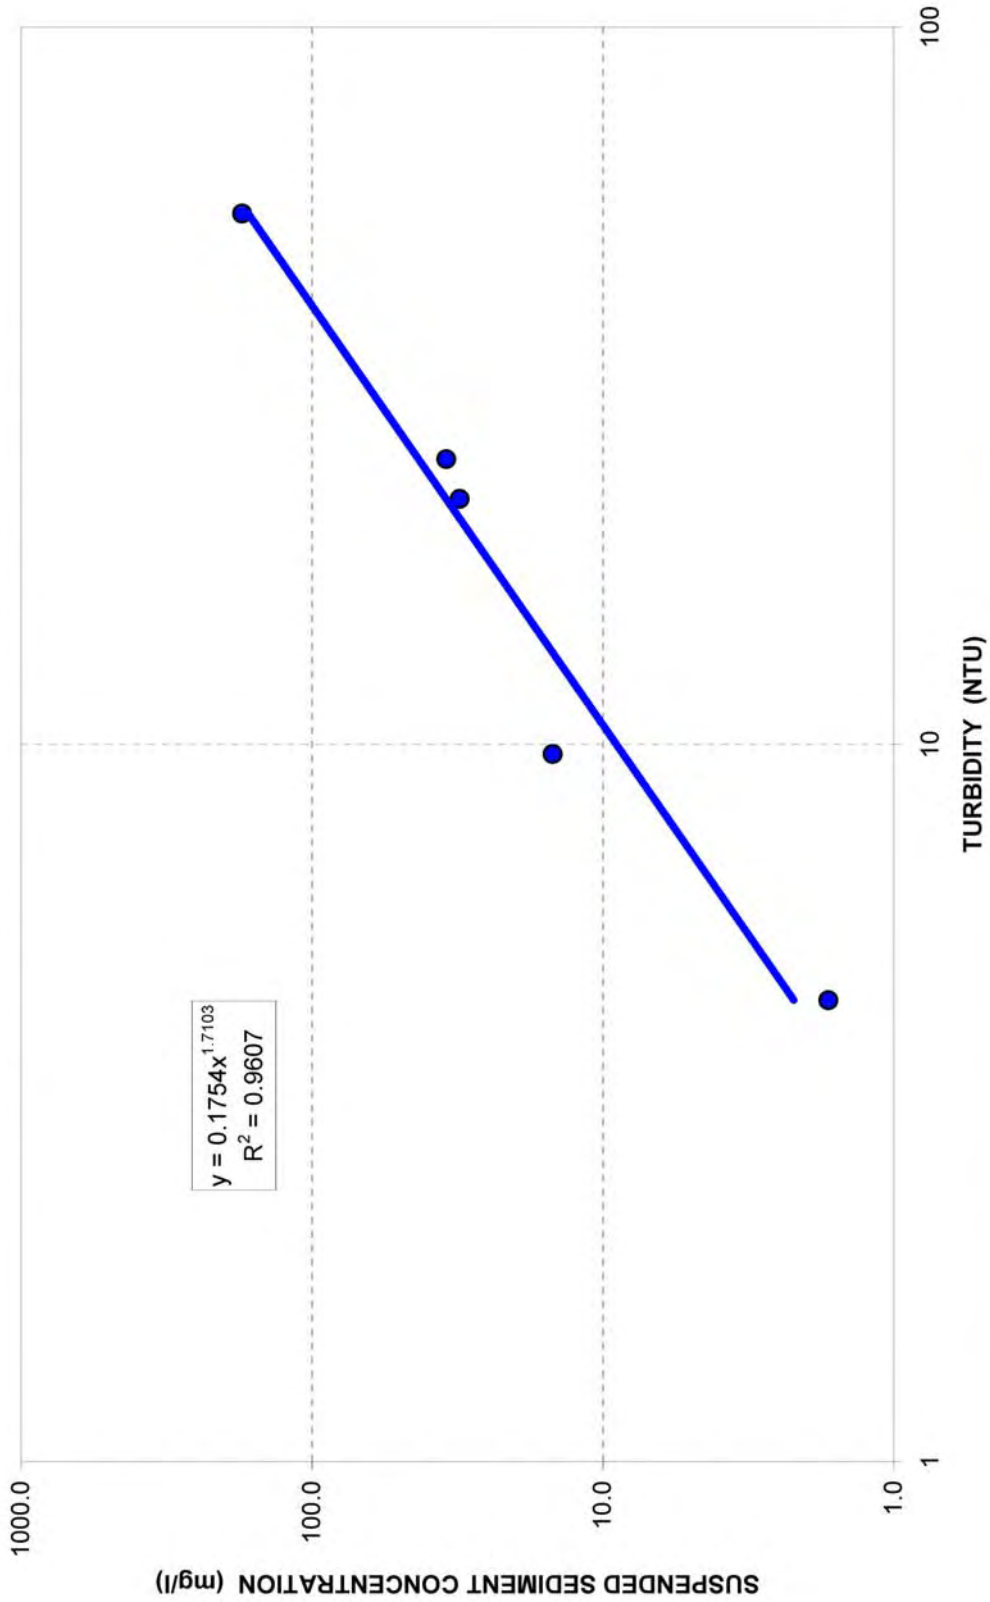
SUMMIT CREEK AT SUMMIT CREEK ROAD
 Turbidity vs Suspended Sediment Concentration, All WY2001-2003 Data

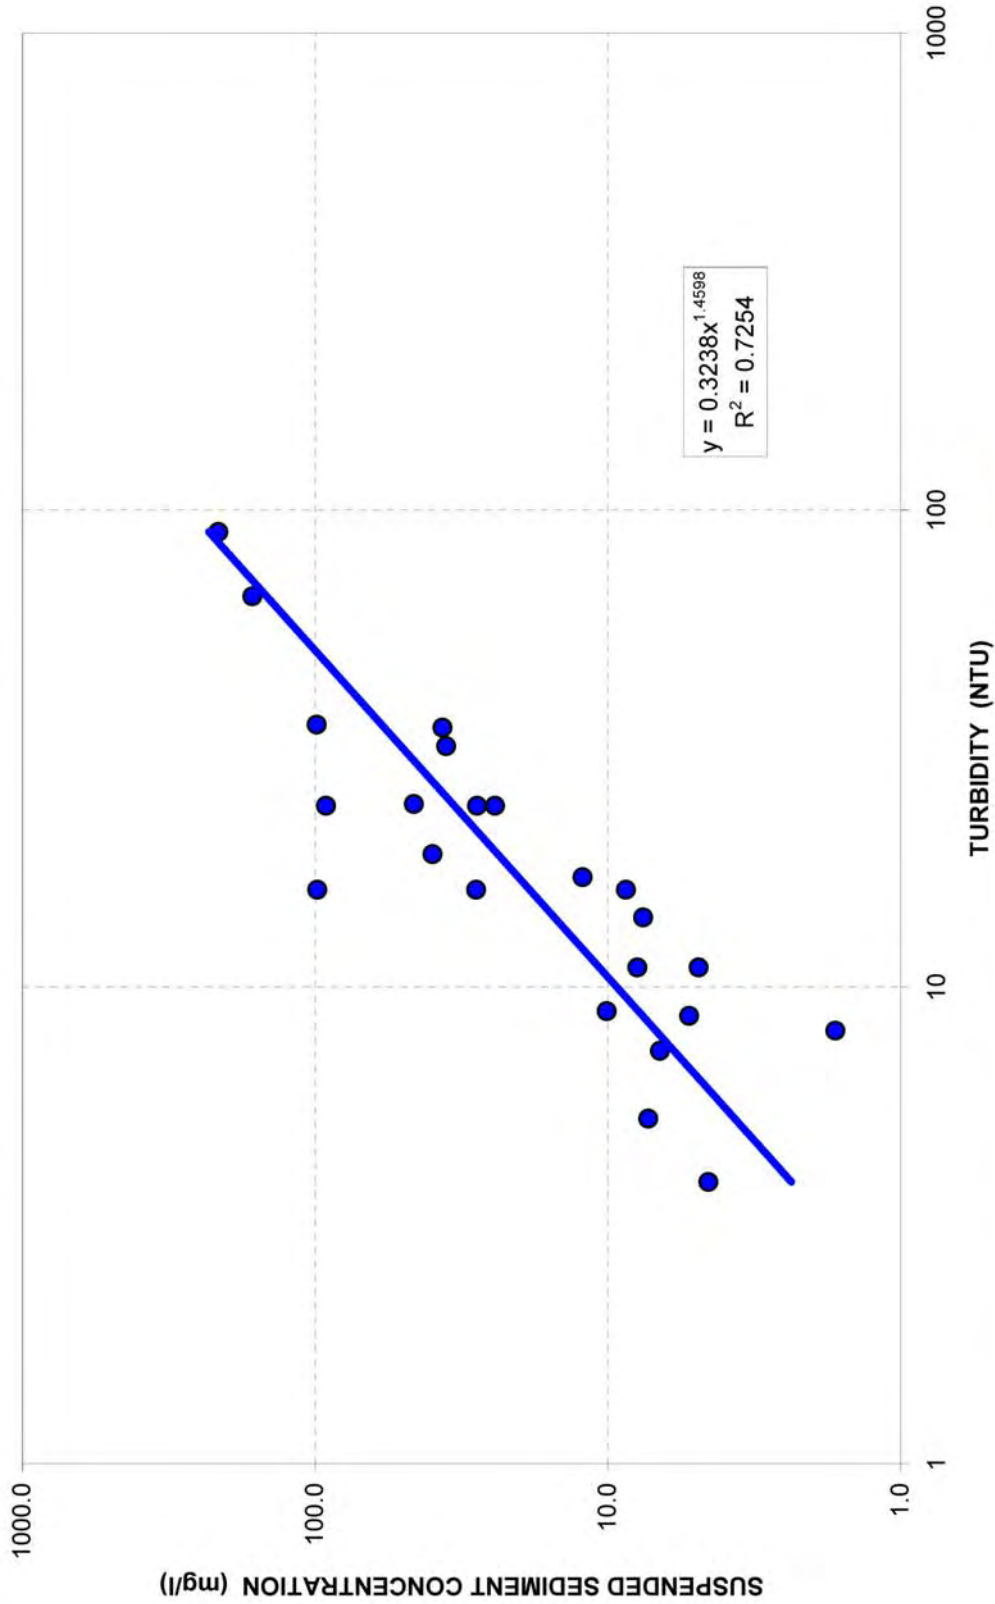
CARR CREEK AT HIGHWAY 3
 Turbidity vs Suspended Sediment Concentration, All WY2001-2003 Data

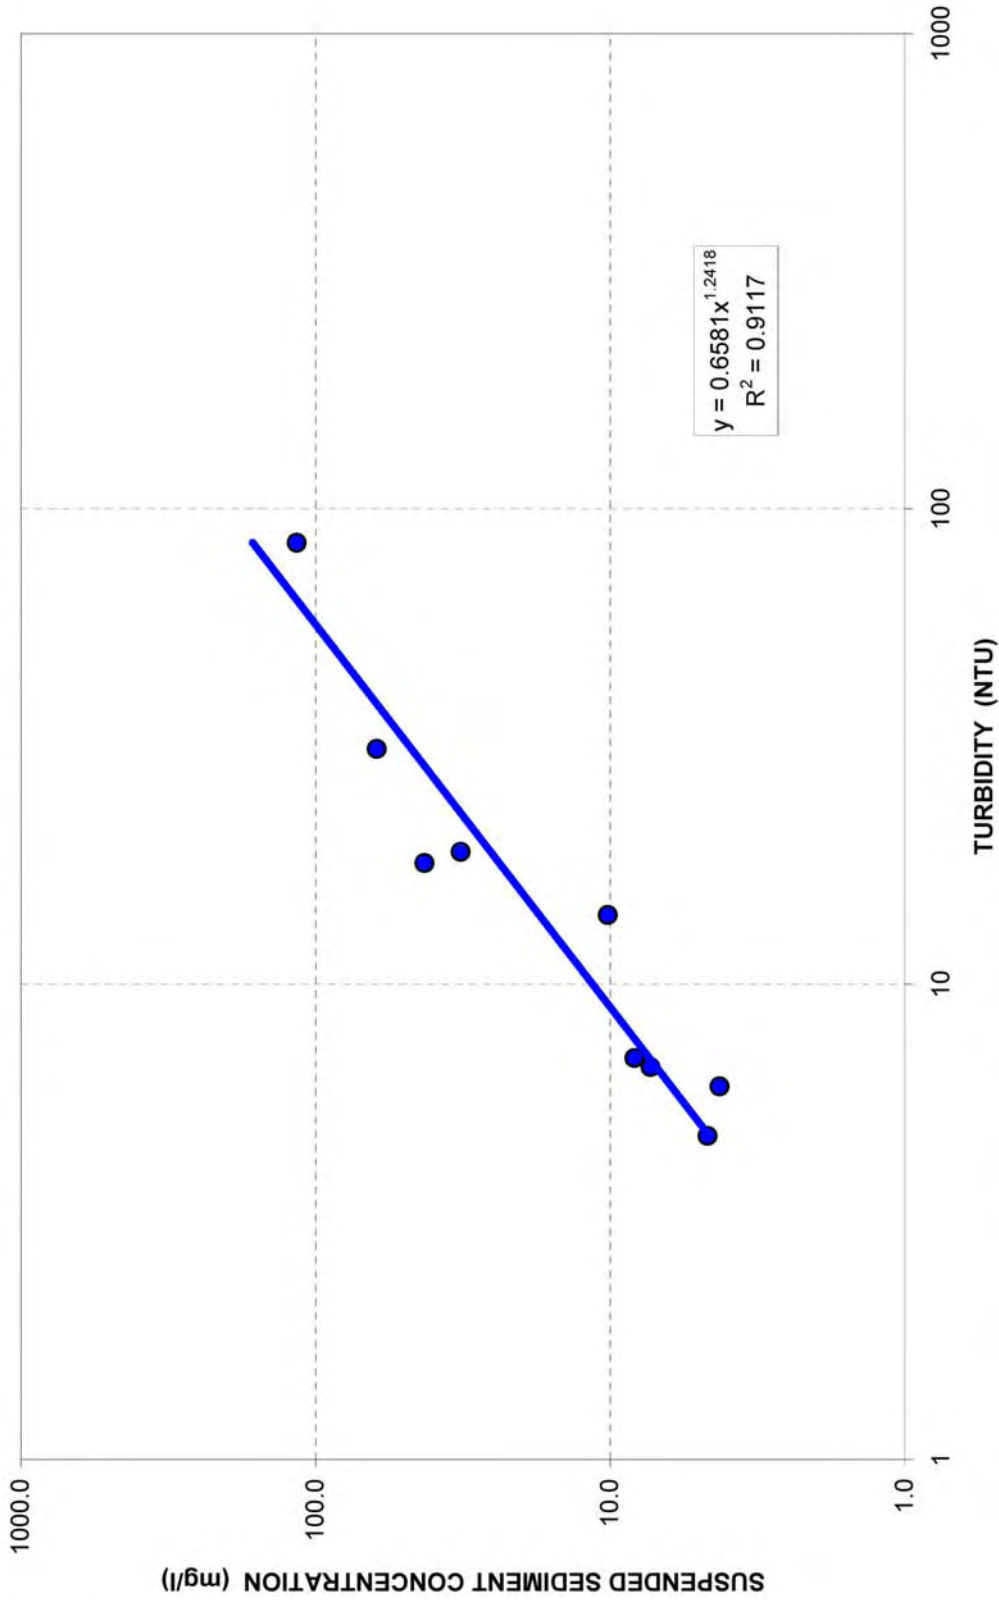
DUNCAN CREEK AT SUMMIT CREEK ROAD
 Turbidity vs Suspended Sediment Concentration, All WY2001-2003 Data

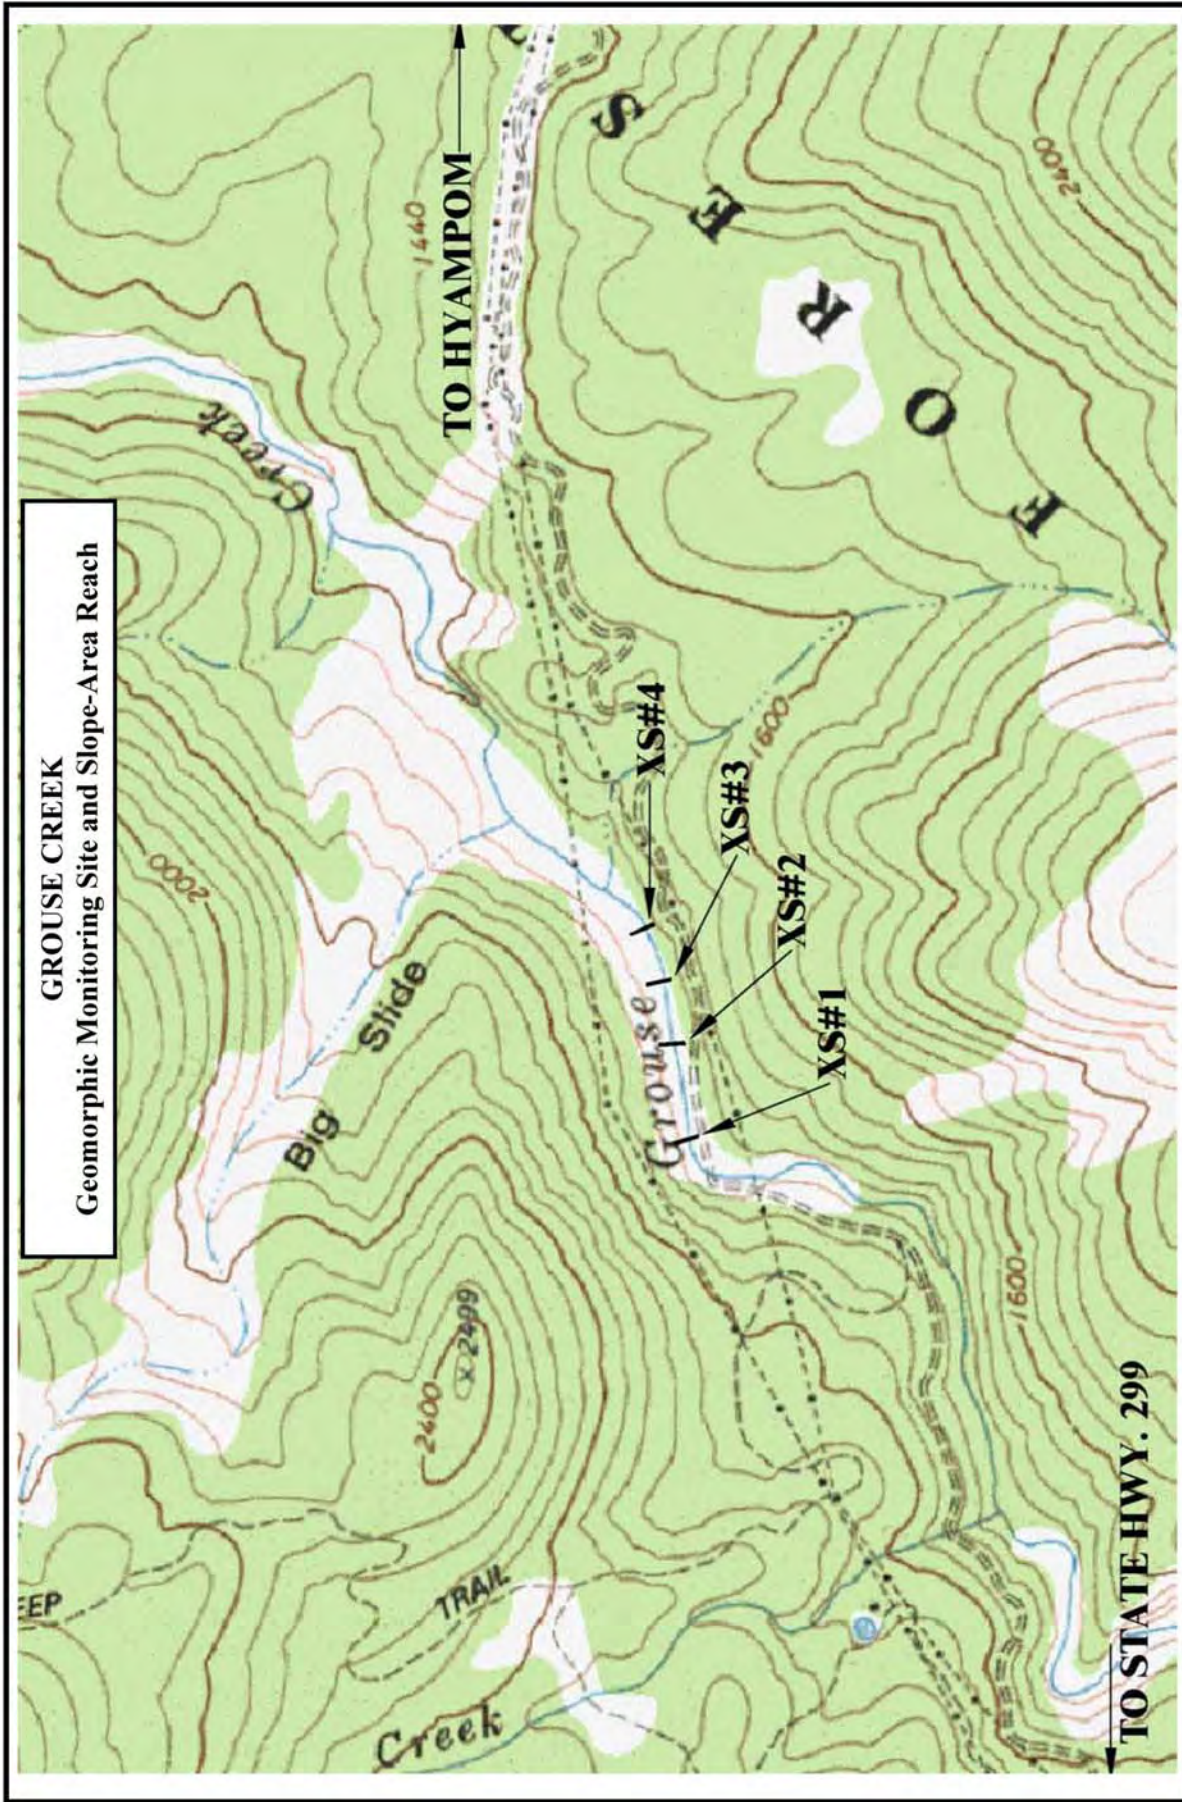
BUTTER CREEK ABOVE SF TRINITY
Geomorphic Monitoring Site and Slope-Area Reach

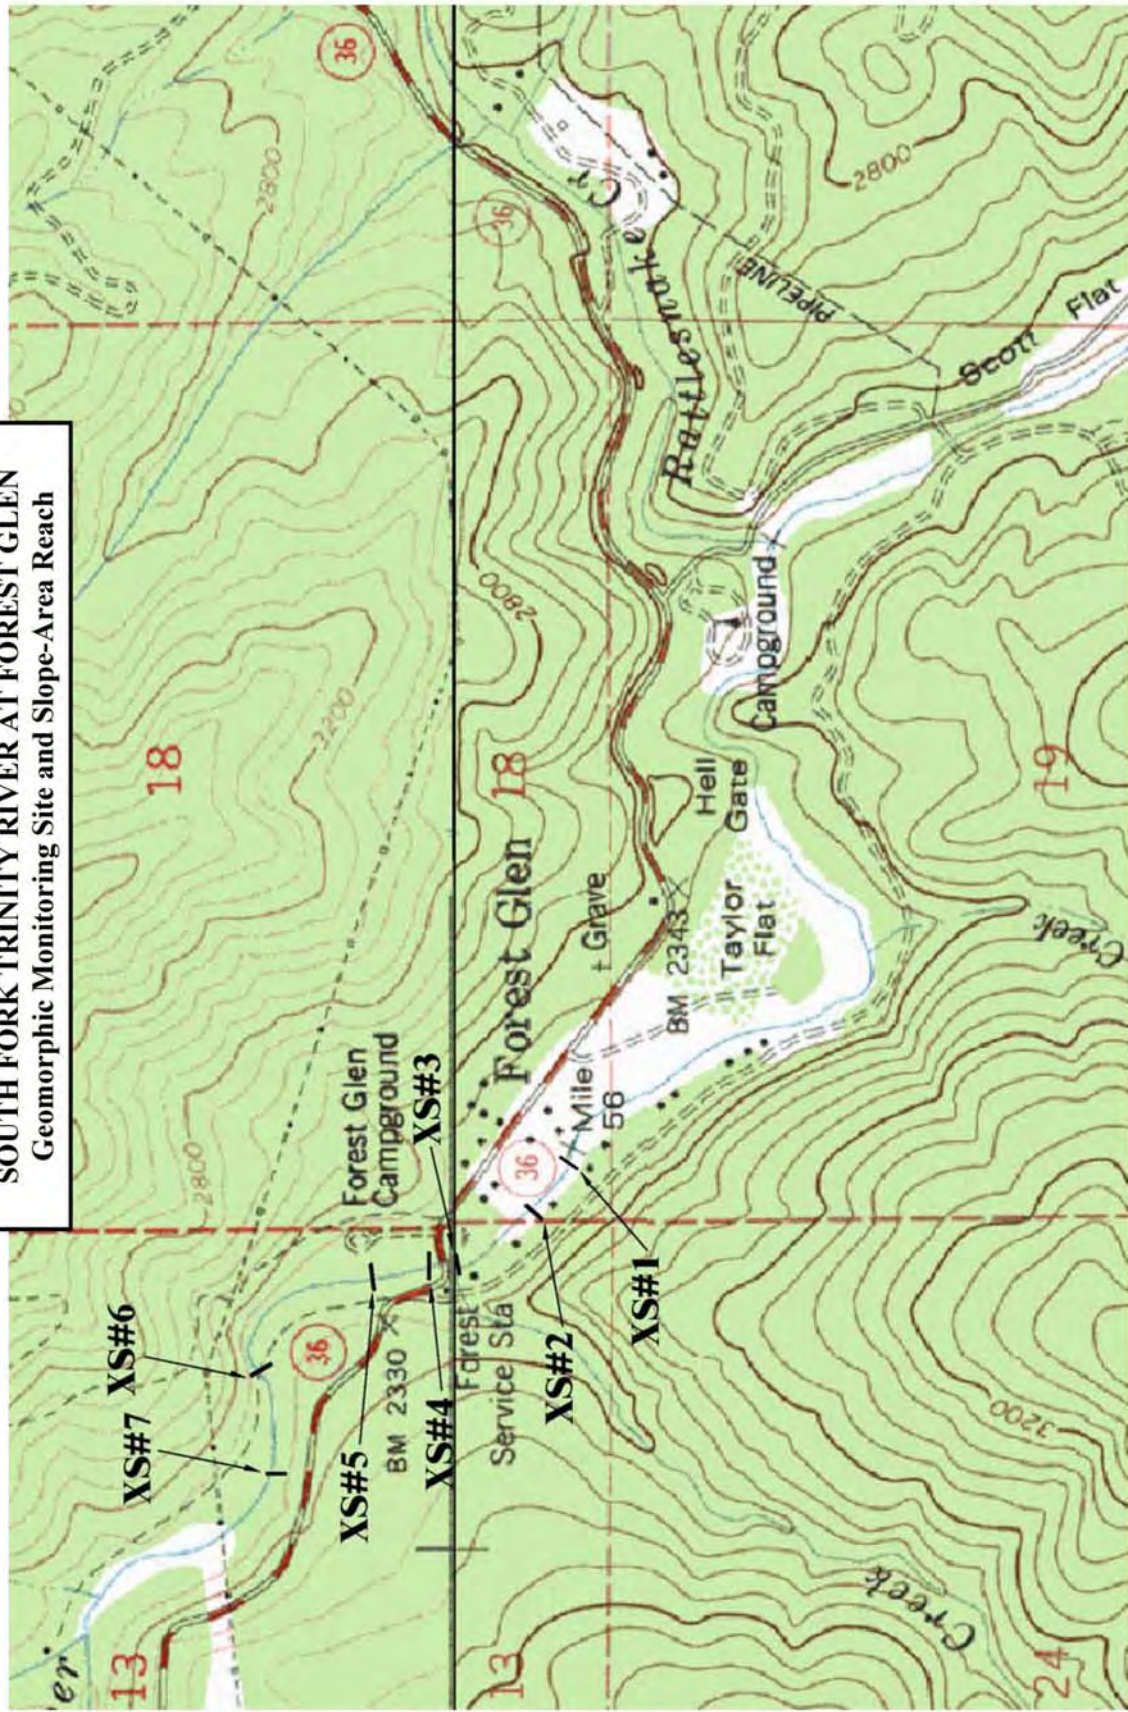
SOUTH FORK TRINITY RIVER AT FOREST GLEN
 Geomorphic Monitoring Site and Slope-Area Reach
